**DEPARTMENT OF TRANSPORTATION**

Contract #: 04-0120F4Cty: SF/ALA Rte: 80 PM: 13.2/13.9File #: 70.28**WELDING INSPECTION REPORT****Resident Engineer:** Pursell, Gary**Address:** 333 Burma Road**City:** Oakland, CA 94607**Report No:** WIR-003836**Date Inspected:** 10-Sep-2008**Project Name:** SAS Superstructure**OSM Arrival Time:** 2300**Prime Contractor:** American Bridge/Fluor Enterprises, a JV**OSM Departure Time:** 700**Contractor:** Japan Steel Works**Location:** Muroran, Japan**CWI Name:** Makhmud Ashadi**CWI Present:** Yes No**Inspected CWI report:** Yes No N/A**Rod Oven in Use:** Yes No N/A**Electrode to specification:** Yes No N/A**Weld Procedures Followed:** Yes No N/A**Qualified Welders:** Yes No N/A**Verified Joint Fit-up:** Yes No N/A**Approved Drawings:** Yes No N/A**Approved WPS:** Yes No N/A**Delayed / Cancelled:** Yes No N/A**Bridge No:** 34-0006**Component:** Tower, Deviation and Jacking Saddles**Summary of Items Observed:**

# WELDING INSPECTION REPORT

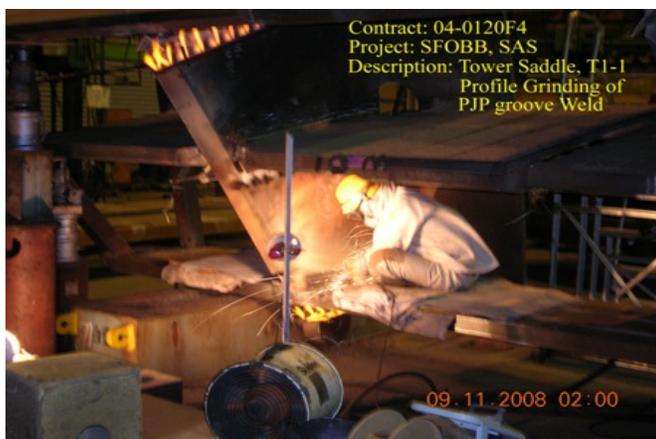
Later in the shift the QA inspector observed JSW personnel, Satoru Watanabe performing the profile grinding on the PJP groove welds identified as 7Y-5V (1-2) and 7Y-5V (1-3). The profile grinding was not completed during this shift on this date.

See Weld Joints in Progress Inspected, below, in regards to QA observation of the welding parameters recorded during this shift on this date for the PJP groove welds identified as 7Y-5V(1-2). The following digital photograph illustrate the observations of the activities performed on this date.
