DEPARTMENT OF TRANSPORTATION

Contract #: 04-0120F4Cty: SF/ALA Rte: 80 PM: 13.2/13.9File #: 69.28**WELDING INSPECTION REPORT****Resident Engineer:** Pursell, Gary**Address:** 333 Burma Road**City:** Oakland, CA 94607**Report No:** WIR-003895**Date Inspected:** 12-Sep-2008**Project Name:** SAS Superstructure**OSM Arrival Time:** 2300**Prime Contractor:** American Bridge/Fluor Enterprises, a JV**OSM Departure Time:** 730**Contractor:** Zhenhua Port Machinery Company, Ltd (ZPMC), Changxing Island **Location:** Shanghai, China**CWI Name:** Sun Bo**CWI Present:** Yes No**Inspected CWI report:** Yes No N/A**Rod Oven in Use:** Yes No N/A**Electrode to specification:** Yes No N/A**Weld Procedures Followed:** Yes No N/A**Qualified Welders:** Yes No N/A**Verified Joint Fit-up:** Yes No N/A**Approved Drawings:** Yes No N/A**Approved WPS:** Yes No N/A**Delayed / Cancelled:** Yes No N/A**Bridge No:** 34-0006**Component:** OBG**Summary of Items Observed:**

Caltrans Quality Assurance (QA) Inspector, Larry Viars was present to observe the Production Monitoring Test (PMT) for Orthotropic Box Girder (OBG) Deck panels, for the San Francisco Oakland Bay Self Anchored Suspension Bridge, at Zhenhua Por

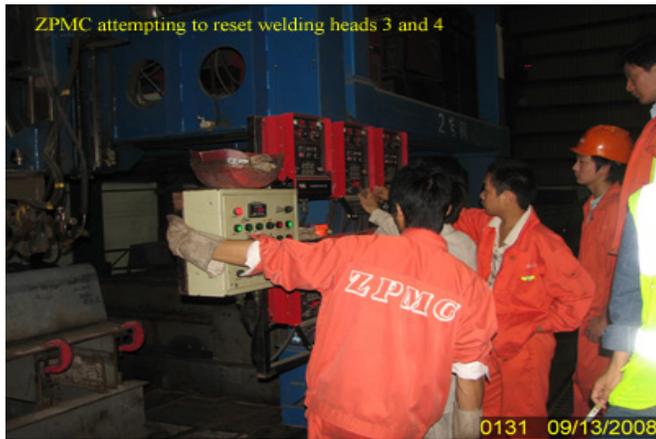
The Caltrans QA Inspector monitored the OBG Production Monitoring Test (PMT) for Deck Panel DP389-001. Prior to Gas Metal Arc Welding (GMAW) root gap measurements and visual inspection of tack welding were found to be compliant with contract documents. During the first PMT Gantry # 2 welding heads # 3 and # 4 malfunctioned on the Submerged Arc Welding (SAW) pass. ZPMC personnel could not remedy the problem and failed the PMT. A new set of Deck plates (3) were moved to Gantry 1. ZPMC personnel ground the tack welds performed MT and visual testing of the root gap and tack welds were performed by ZPMC, ABF and Caltrans. The Caltrans QA inspector recorded amperage, voltage and travel speed of the Gas metal Arc Welding (GMAW) root pass and the Submerged Arc Welding (SAW) cover pass. A Visual inspection of the root pass and cover pass was performed by ZPMC, American Bridge Flour (ABF) and the Caltrans QA. The Caltrans QA observed ZPMC QC Xue Hai Rong perform Ultrasonic testing of the Partial Joint Penetration weld for depth of penetration. Mr. Xue found the depth of penetration of the PMT welds to be in compliance with contract documents. The Caltrans QA inspector designated locations for Macroetch samples (15 locations). Macroetch samples were evaluated with a 7x optical comparator and PMT #2 was found acceptable by ZPMC QC, ABF QC and The Caltrans QA Inspector.

DP389-001- Tack welding completed, grinding not complete. ZPMC stated MT will be performed on day Shift.
