Contract #: 04-0120F4Cty: SF/ALA Rte: 80 PM: 13.2/13.9File #: 69.28**WELDING INSPECTION REPORT****Resident Engineer:** Pursell, Gary**Address:** 333 Burma Road**City:** Oakland, CA 94607**Report No:** WIR-003907**Date Inspected:** 17-Sep-2008**Project Name:** SAS Superstructure**OSM Arrival Time:** 630**Prime Contractor:** American Bridge/Fluor Enterprises, a JV**OSM Departure Time:** 1430**Contractor:** Zhenhua Port Machinery Company, Ltd (ZPMC), Changxing Island **Location:** Shanghai, China**CWI Name:** Wang Sei Fa**CWI Present:** Yes No**Inspected CWI report:** Yes No N/A**Rod Oven in Use:** Yes No N/A**Electrode to specification:** Yes No N/A**Weld Procedures Followed:** Yes No N/A**Qualified Welders:** Yes No N/A**Verified Joint Fit-up:** Yes No N/A**Approved Drawings:** Yes No N/A**Approved WPS:** Yes No N/A**Delayed / Cancelled:** Yes No N/A**Bridge No:** 34-0006**Component:** Tower Skin Plates**Summary of Items Observed:**

WELDING INSPECTION REPORT

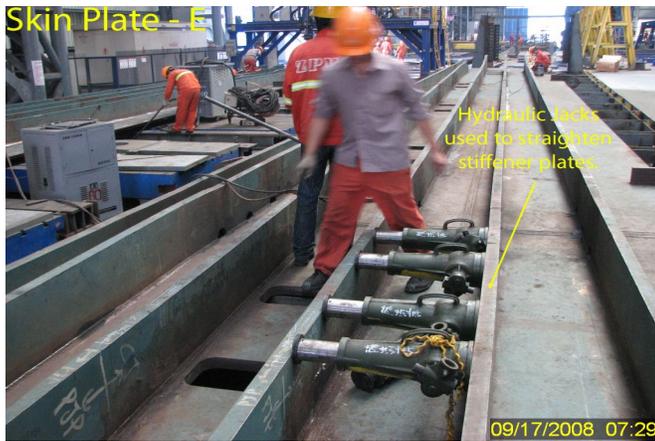
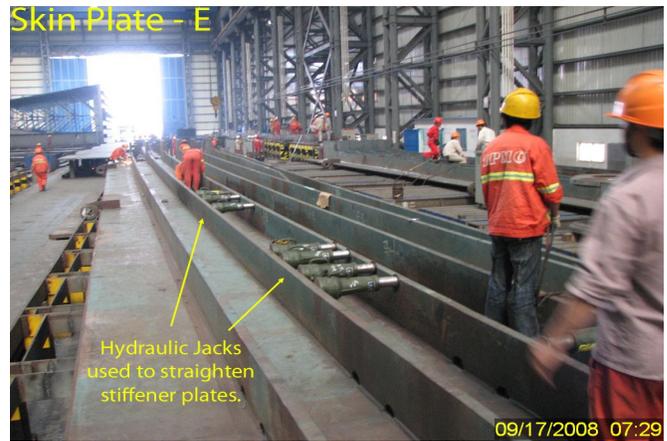
This QA Inspector observed mechanical straightening by ZPMC personnel of longitudinal stiffeners previously welded to skin plate East-E. This QA Inspector recorded this event in digital photographs filed with this report.
