DEPARTMENT OF TRANSPORTATION

Quality Assurance and Source Inspection

Contract #: 04-0120F4Cty: SF/ALA Rte: 80 PM: 13.2/13.9File #: 69.28**WELDING INSPECTION REPORT****Resident Engineer:** Pursell, Gary**Address:** 333 Burma Road**City:** Oakland, CA 94607**Report No:** WIR-000014**Date Inspected:** 29-Nov-2006**Project Name:** SAS Superstructure**OSM Arrival Time:** 800**Prime Contractor:** American Bridge/Fluor Enterprises, a JV**OSM Departure Time:** 1500**Contractor:** Zhenhua Port Machinery Company, Ltd (ZPMC), Changxing Island **Location:** Shanghai, China**CWI Name:** Liu Liu and Cheng Li Bin**CWI Present:** Yes No**Inspected CWI report:** Yes No N/A**Rod Oven in Use:** Yes No N/A**Electrode to specification:** Yes No N/A**Weld Procedures Followed:** Yes No N/A**Qualified Welders:** Yes No N/A**Verified Joint Fit-up:** Yes No N/A**Approved Drawings:** Yes No N/A**Approved WPS:** Yes No N/A**Delayed / Cancelled:** Yes No N/A**Bridge No:** 34-0006**Component:** n/a**Summary of Items Observed:**

Office of Structural Materials Quality Assurance Inspector (QA), David McClary observed quality control functions related to procedure qualification (PQR) testing at the ZPMC facility

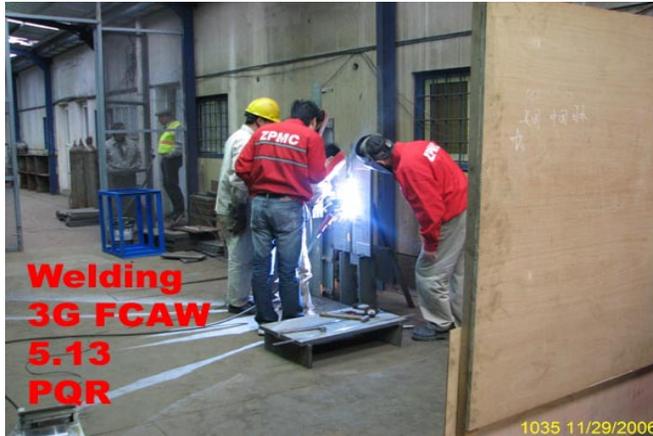
Item	Description	WBS	Dwg No.	Status
1	PQR HP-2006118			Welded
	The QA Inspector observed welding of a Procedure Qualification (PQR) test plate identified as HP-2006118. The test was conducted using Flux Cored Arc Welding (FCAW), Hyundai Supercored 71H, electrode in the 3G (vertical) position. The QA Inspector observed ZPMC Quality Control (QC) recording the essential variable (amps, volts, travel speed) for each pass and randomly verified the parameters using an Amprobe® amperage / voltage meter and a stopwatch. The average parameters for the PQR were recorded as 202.9 amps, 25.7 volts, 112.9mm/min travel speed and a Heat Input of 2.77 KJ/mm. The welding appeared to comply with the contract documents.			
	Lot Number B60-022-06 was assigned for tracking purposes. See TL-6032 for additional details.

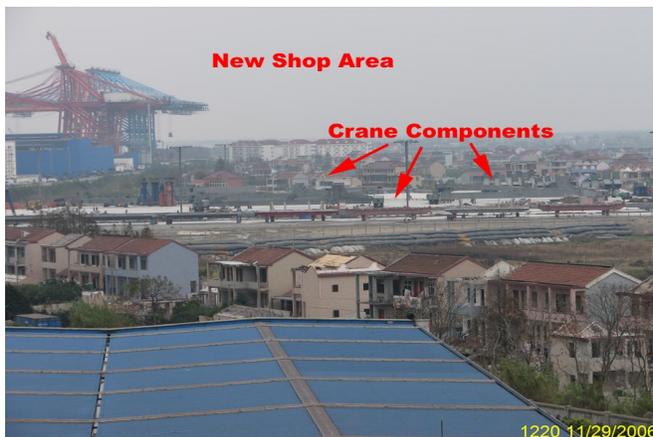
2 New Fabrication Facility Under Construction

The QA Inspector observed large components in the area of the new shop facility that ZPMC is building to construct this bridge. The QA Inspector asked ABF Quality Control Manager (QCM) Jim Bowers if this was part of the building construction or possibly the overhead crane system. Mr. Bowers did not know. ABF and Caltrans are scheduled to observe construction on the facility tomorrow. After review of the photographs taken, the large components appear to be container crane components.
