Quality Assurance and Source Inspection

Contract #: 04-0120F4Cty: SF/ALA Rte: 80 PM: 13.2/13.9File #: 69.28**WELDING INSPECTION REPORT****Resident Engineer:** Pursell, Gary**Address:** 333 Burma Road**City:** Oakland, CA 94607**Report No:** WIR-000069**Date Inspected:** 05-Dec-2006**Project Name:** SAS Superstructure**OSM Arrival Time:** 800**Prime Contractor:** American Bridge/Fluor Enterprises, a JV**OSM Departure Time:** 1700**Contractor:** Zhenhua Port Machinery Company, Ltd (ZPMC), Changxing Island **Location:** Shanghai, China**CWI Name:** Huang Wei**CWI Present:** Yes No**Inspected CWI report:** Yes No N/A**Rod Oven in Use:** Yes No N/A**Electrode to specification:** Yes No N/A**Weld Procedures Followed:** Yes No N/A**Qualified Welders:** Yes No N/A**Verified Joint Fit-up:** Yes No N/A**Approved Drawings:** Yes No N/A**Approved WPS:** Yes No N/A**Delayed / Cancelled:** Yes No N/A**Bridge No:** 34-0006**Component:** N/A**Summary of Items Observed:**

WELDING INSPECTION REPORT

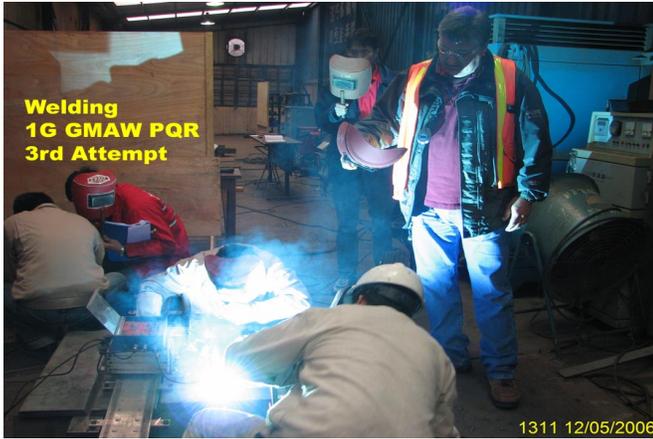
The QA Inspector observed welding of a Procedure Qualification (PQR) test plate identified as HP-2006119-2 (3rd test). The test was conducted using Gas Metal Arc Welding (GMAW), Supertech SM-70, electrode in the 1G (flat) position to AWS D1.5, Section 5.13 (Production Procedure). ZPMC Quality Control (QC) observed micro-porosity in the ninth pass, which was subsequently removed by. The QA Inspector observed ZPMC Quality Control (QC) recording the essential variable (amps, volts, travel speed) for each pass and randomly verified the parameters using an Fluke® amperage / voltage meter and a stopwatch. The welding appeared to comply with the contract documents. See TL-6032 by QA Inspector Mark Wright for additional details.

ZPMC Quality Control (QC) Mr. Lu Hua informed the QA Inspector that the Radiographic Testing (RT) film for the 1G FCAW PQR, 3rd test, was rejected by ZPMC Quality Control for lack of fusion. ZPMC was backgouging into the PQR plate to determine the depth of the lack of fusion.
