**DEPARTMENT OF TRANSPORTATION**

Contract #: 04-0120F4Cty: SF/ALA Rte: 80 PM: 13.2/13.9File #: 01.28**WELDING INSPECTION REPORT****Resident Engineer:** Pursell, Gary**Address:** 333 Burma Road**City:** Oakland, CA 94607**Report No:** WIR-000156**Date Inspected:** 07-May-2007**Project Name:** SAS Superstructure**OSM Arrival Time:** 630**Prime Contractor:** American Bridge/Fluor Enterprises, a JV**OSM Departure Time:** 1500**Contractor:** American Bridge/Fluor Enterprises, a JV**Location:** Benicia, CA

**Bridge No:** 34-0006**Component:** Procedure Qualification Record (PQR) Test**Summary of Items Observed:**

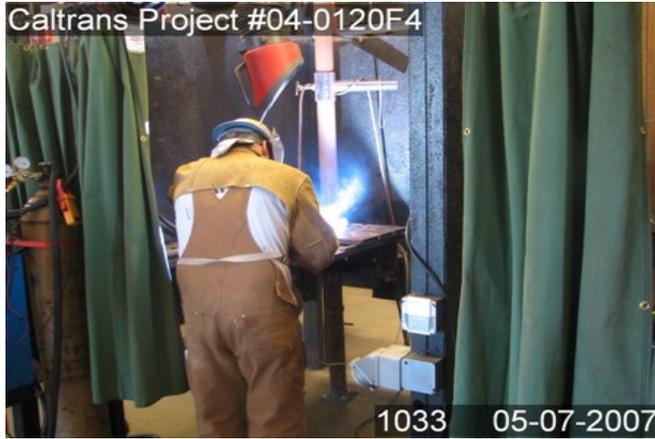
The QA Inspector observed welder Dan Gordon welding multiple practice test plates in preparation for a minimum heat input Procedure Qualification Record (PQR) Test identified as ABF-PQR-013-2. Under the direction of ABF Representative Mr. Tommy Gibson, Mr. Gordon welded the root pass and two subsequent weld passes in the flat position on each of the practice test plates. After welding of the practice test plates was completed, Mr. Gibson cut multiple cross sections from the plate in an effort to determine the quality of the weld and to ensure that the machine settings were correct before proceeding with the PQR Test. During welding of the practice test plates, the QA Inspector recorded an average of approximately 256 amps and 23.3 volts at Mr. Gordon's station. The following digital photograph illustrates Mr. Gordon in the process of welding one of the practice test plates in the flat position.
