DEPARTMENT OF TRANSPORTATION

Quality Assurance and Source Inspection

Contract #: 04-0120F4Cty: SF/ALA Rte: 80 PM: 13.2/13.9File #: 69.28**WELDING INSPECTION REPORT****Resident Engineer:** Pursell, Gary**Address:** 333 Burma Road**City:** Oakland, CA 94607**Report No:** WIR-000170**Date Inspected:** 16-May-2007**Project Name:** SAS Superstructure**OSM Arrival Time:** 800**Prime Contractor:** American Bridge/Fluor Enterprises, a JV**OSM Departure Time:** 1530**Contractor:** Zhenhua Port Machinery Company, Ltd (ZPMC), Changxing Island **Location:** Shanghai, China**CWI Name:** Huang Wei**CWI Present:** Yes No**Inspected CWI report:** Yes No N/A**Rod Oven in Use:** Yes No N/A**Electrode to specification:** Yes No N/A**Weld Procedures Followed:** Yes No N/A**Qualified Welders:** Yes No N/A**Verified Joint Fit-up:** Yes No N/A**Approved Drawings:** Yes No N/A**Approved WPS:** Yes No N/A**Delayed / Cancelled:** Yes No N/A**Bridge No:** 34-0006**Component:** N/A**Summary of Items Observed:**

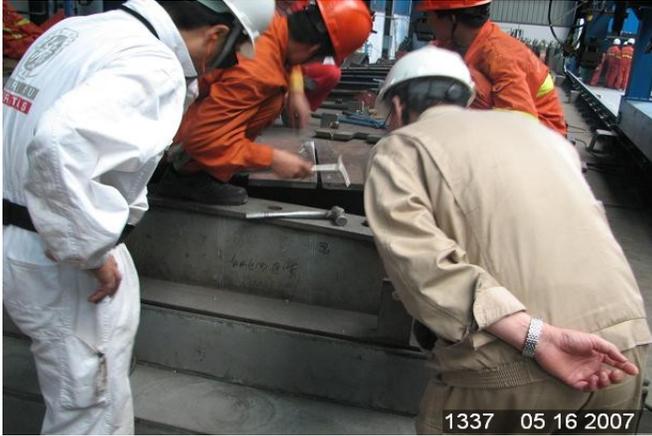
Before the welding started, the QA inspector had a conversation with the ABF representative Song Wemin. The QA inspector brought to the attention of Mr. Song that the steel backing bar used on the PQR HP200785 had 12 mm thickness in lieu of 10 mm as per mill test report and PWPS presented by ZPMC. Mr. Song agreed and requested to ZPMC to remove the steel backing bar. ZPMC decided to fit up a second test plate with materials listed on the mill test reports. The digital photograph below shows ZPMC reinstalling the test plate HP200785.
