Contract #: 04-0120F4Cty: SF/ALA Rte: 80 PM: 13.2/13.9File #: 69.28**WELDING INSPECTION REPORT****Resident Engineer:** Pursell, Gary**Address:** 333 Burma Road**City:** Oakland, CA 94607**Report No:** WIR-000236**Date Inspected:** 21-Jun-2007**Project Name:** SAS Superstructure**OSM Arrival Time:** 800**Prime Contractor:** American Bridge/Fluor Enterprises, a JV**OSM Departure Time:** 1700**Contractor:** Zhenhua Port Machinery Company, Ltd (ZPMC), Changxing Island **Location:** Shanghai, China**CWI Name:** Mr. Zhou Daging**CWI Present:** Yes No**Inspected CWI report:** Yes No N/A**Rod Oven in Use:** Yes No N/A**Electrode to specification:** Yes No N/A**Weld Procedures Followed:** Yes No N/A**Qualified Welders:** Yes No N/A**Verified Joint Fit-up:** Yes No N/A**Approved Drawings:** Yes No N/A**Approved WPS:** Yes No N/A**Delayed / Cancelled:** Yes No N/A**Bridge No:** 34-0006**Component:** Welder Qualification Testing**Summary of Items Observed:**

Caltrans Quality Assurance (QA) Inspector Robert Cuellar is present at the fabrication facility of Zhenhua Port Machinery Company (ZPMC), LTD for the purpose of monitoring activities relative to the subsequent fabrication of the SFOBB Sel

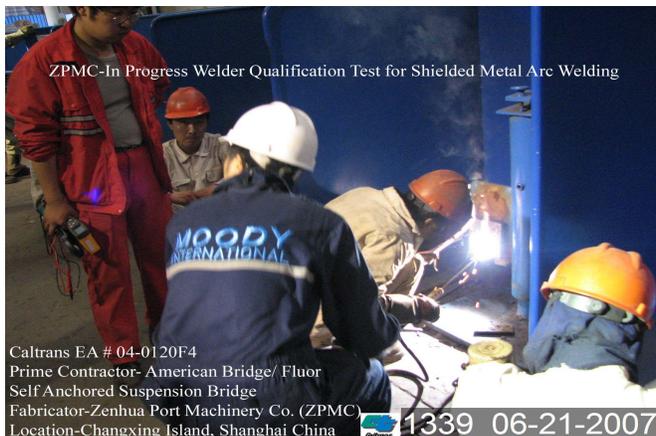
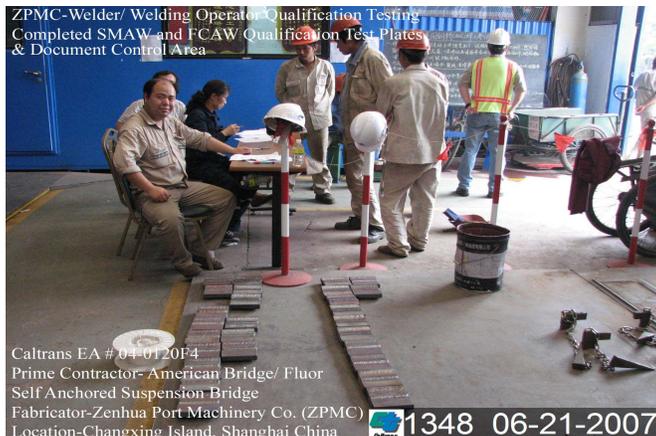
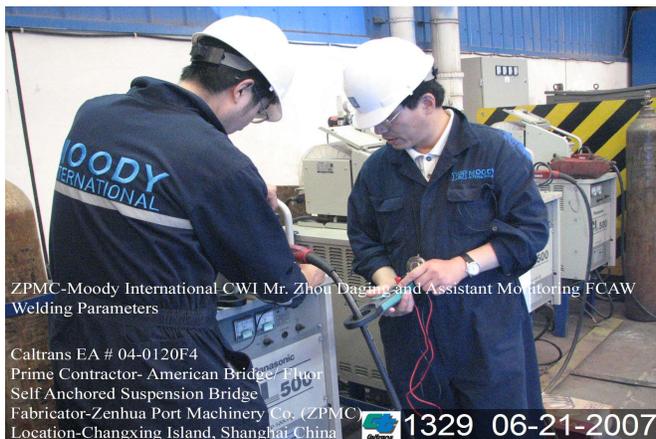
The Caltrans QA Inspector was accompanied by ZPMC representative Mr. Xu Jun, ABF representatives Mr. Kevin Dye, Dustin Brungardt and Caltrans Structures Construction representative Mr. Stan Ku for the purpose of traveling to a remote ZPMC location on Changxing Island for the observation of in process Welder and Welding Operator qualification tests. As previously addressed this test facility of ZPMC is an established Welder/ Welding Operator qualification test facility at an area located approximately 15 to 20 minutes traveling by car from the main facility in Changxing Island. The Caltrans QA Inspector observed numerous Welder's and Welding Operator's in process of attempting qualification utilizing the shielded metal arc welding (SMAW) process, the flux cored arc welding (FCAW) process and also the submerged arc welding (SAW) process. The Caltrans QA Inspector observed that there are Moody International Representatives who are performing the monitoring of these Welder/Welding Operator Qualification tests. The Caltrans QA Inspector observed that there is a Moody International Certified Welding Inspector (CWI) identified as Mr. Zhou Daging with three assistants that are monitoring the Welder and Welding Operator qualification testing. Based on information provided by Mr. Zhou Daging there are twenty-three (23) welders attempting qualification testing utilizing the flux cored arc welding (FCAW) process, nineteen (19) are attempting qualification testing utilizing the shielded metal arc welding process and five (5) are attempting welder operator qualification utilizing the submerged arc welding (SAW) process. These tests are all being attempted for

qualification for unlimited thickness. Below are digital pictures of the Caltrans QA Inspector's observation of the activities being performed.

Based on random observations it appears that the observed welder/ welding operator qualification testing being performed is progressing in general compliance with AWS D1.5 (2002).
