DEPARTMENT OF TRANSPORTATION

Contract #: 04-0120F4Cty: SF/ALA Rte: 80 PM: 13.2/13.9File #: 01.28**WELDING INSPECTION REPORT****Resident Engineer:** Pursell, Gary**Address:** 333 Burma Road**City:** Oakland, CA 94607**Report No:** WIR-000298**Date Inspected:** 19-Jul-2007**Project Name:** SAS Superstructure**OSM Arrival Time:** 630**Prime Contractor:** American Bridge/Fluor Enterprises, a JV**OSM Departure Time:** 1700**Contractor:** American Bridge/Fluor Enterprises, a JV**Location:** Benicia, CA**CWI Name:** Michael Johnson**CWI Present:** Yes No**Inspected CWI report:** Yes No N/A**Rod Oven in Use:** Yes No N/A**Electrode to specification:** Yes No N/A**Weld Procedures Followed:** Yes No N/A**Qualified Welders:** Yes No N/A**Verified Joint Fit-up:** Yes No N/A**Approved Drawings:** Yes No N/A**Approved WPS:** Yes No N/A**Delayed / Cancelled:** Yes No N/A**Bridge No:** 34-0006**Component:** Procedure Qualification Record (PQR) Test**Summary of Items Observed:**

WELDING INSPECTION REPORT

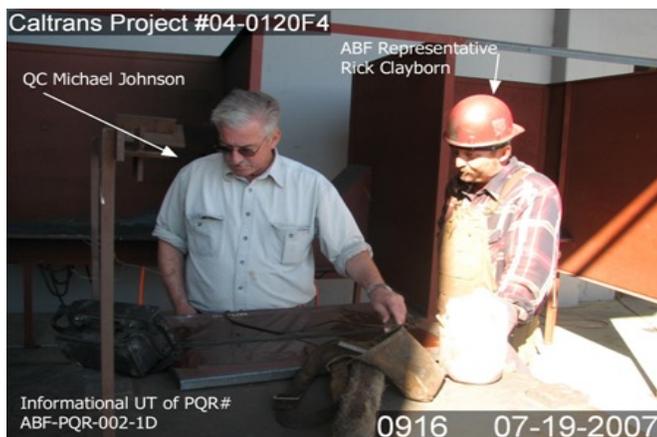
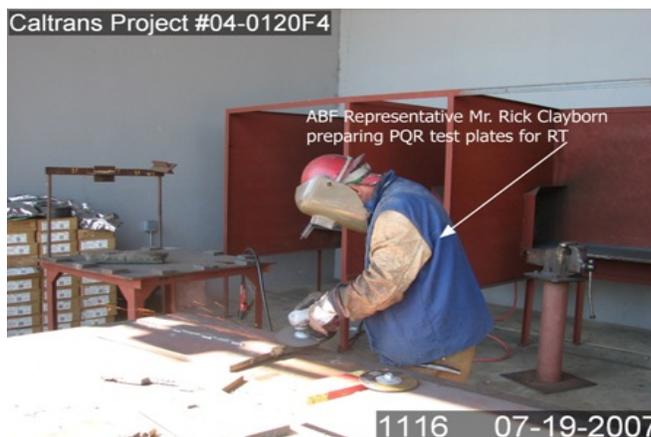
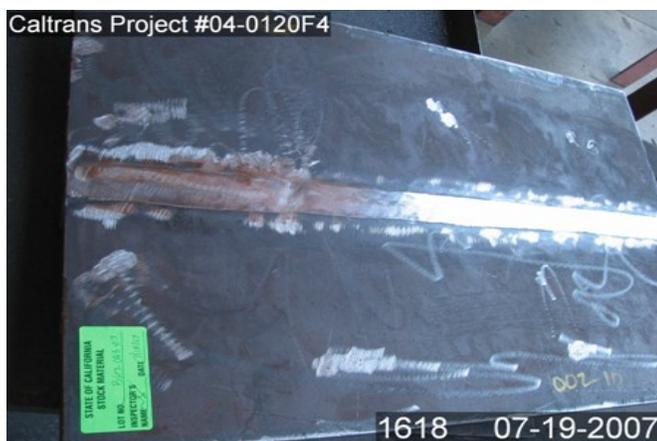
The QA Inspector observed the continuation of the first attempt of a PQR test identified as ABF-PQR-002-2. This PQR test is being attempted using the flux-cored arc welding (FCAW) process and a mechanical device that travels on a magnetic track. Welder Dan Gordon deposited seven on this date. For specific welding parameters recorded during this PQR and digital photographs that support these observations, see Caltrans Welding Witness Report, TL-6032 generated on this date.

The QA Inspector observed Quality Control Representative Mr. Michael Johnson as he performed ultrasonic testing (UT) on one completed PQR test plate for information purposes only. Mr. Johnson used a seventy degree angle for this informational inspection. At the completion of testing, Mr. Johnson informed the QA Inspector that UT of the PQR test plate identified as ABF-PQR-002-1D revealed multiple indications in the root pass with an indication rating of +14 dbs.

The QA Inspector performed a random visual inspection of the completed PQR test plate identified as ABF-PQR-002-1D after removal of the weld reinforcement in preparation for radiographic testing. The QA Inspector then applied a green tag containing lot number B67-043-07 to the test plate. This PQR test plate will be

sent out for radiographic testing sometime this week.
