DEPARTMENT OF TRANSPORTATION

Quality Assurance and Source Inspection

Contract #: 04-0120F4Cty: SF/ALA Rte: 80 PM: 13.2/13.9File #: 1.28**WELDING INSPECTION REPORT****Resident Engineer:** Pursell, Gary**Address:** 333 Burma Road**City:** Oakland, CA 94607**Report No:** WIR-000382**Date Inspected:** 27-Aug-2007**Project Name:** SAS Superstructure**OSM Arrival Time:** 700**Prime Contractor:** American Bridge/Fluor Enterprises, a JV**OSM Departure Time:** 1530**Contractor:** American Bridge/Fluor Enterprises, a JV**Location:** Benicia, CA**CWI Name:** Michael Johnson**CWI Present:** Yes No**Inspected CWI report:** Yes No N/A**Rod Oven in Use:** Yes No N/A**Electrode to specification:** Yes No N/A**Weld Procedures Followed:** Yes No N/A**Qualified Welders:** Yes No N/A**Verified Joint Fit-up:** Yes No N/A**Approved Drawings:** Yes No N/A**Approved WPS:** Yes No N/A**Delayed / Cancelled:** Yes No N/A**Bridge No:** 34-0006**Component:** Procedure Qualification Record (PQR) Test**Summary of Items Observed:**

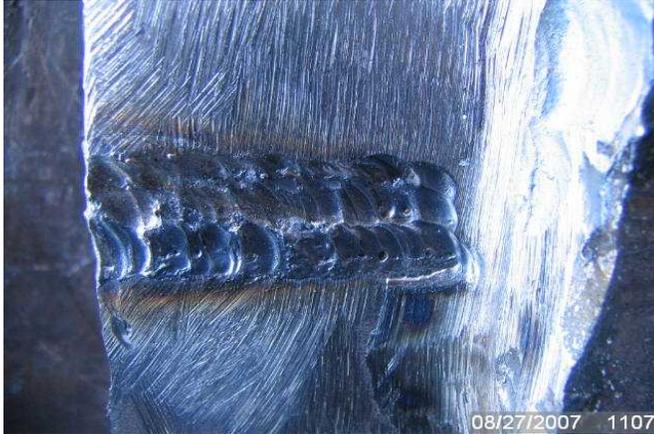
The QA Inspector observed that the welders remove 2 inches of the back-up bar from each end of ABF-PQR-003-1A plate to observe any indications that may exist. The ends of the PQR test plate in which the backing bar was removed are considered discard areas. It was observed that Round Indications were discovered at both locations. See photo below for additional information.
