Contract #: 04-0120F4Cty: SF/ALA Rte: 80 PM: 13.2/13.9File #: 6928**WELDING INSPECTION REPORT****Resident Engineer:** Pursell, Gary**Address:** 333 Burma Road**City:** Oakland, CA 94607**Report No:** WIR-000443**Date Inspected:** 13-Sep-2007**Project Name:** SAS Superstructure**OSM Arrival Time:** 1400**Prime Contractor:** American Bridge/Fluor Enterprises, a JV**OSM Departure Time:** 2300**Contractor:** Zhenhua Port Machinery Company, Ltd (ZPMC), Changxing Island **Location:** Changxing Island**CWI Name:** Xu Bing**CWI Present:** Yes No**Inspected CWI report:** Yes No N/A**Rod Oven in Use:** Yes No N/A**Electrode to specification:** Yes No N/A**Weld Procedures Followed:** Yes No N/A**Qualified Welders:** Yes No N/A**Verified Joint Fit-up:** Yes No N/A**Approved Drawings:** Yes No N/A**Approved WPS:** Yes No N/A**Delayed / Cancelled:** Yes No N/A**Bridge No:** 34-0006**Component:** 114 A,C and 77 A**Summary of Items Observed:**

Caltrans Quality Assurance (QA) Inspector, Larry Viars was present to observe the welding of the Caltrans Mock-up #114.00 and #77.00, for the San Francisco Oakland Self Anchored Suspension Bridge, at Zhenhua Port Machinery Company (ZPMC) facility on Changxi

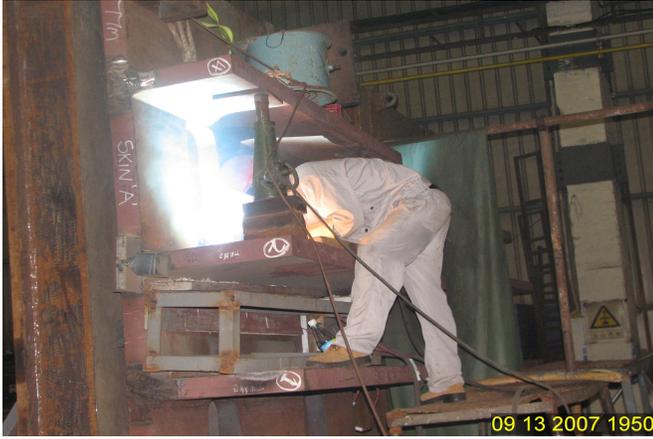
Caltrans QA Inspector observed ZPMC shop personnel performing Flux Core Arc welding (FCAW) at #77.00 Skin Plate C Stiffener welds. ZPMC QA Inspector Fu Yuhong stated, FCAW is being performed in accordance to WPS-345-FCAW-1G(1F) repair-1 and the welder performing the welding Mr. Li Ming Yang. The following digital picture illustrates FCAW in progress. Caltrans QA Inspector observed Stiffener fit up of Mock up 144.00 Skin C stiffeners MP1001 and MP1002 in progress.

Caltrans QA Inspector observed ZPMC QC nondestructive technician, Mr. Xu Bing performing Visual testing (VT). The (VT) testing was performed on Mock-up #77.00 Skin A stiffener #MP2, weld #2 repair weld. Caltrans QA observed ZPMC monitoring welding parameters on the cover pass Skin Plate C stiffener welds. Caltrans QA inspector observed Air Carbon Arc Gouging in progress on Mock up #114.00 Skin C upper Section. The welding and Air Carbon Arc gouging appeared to be in conformance with AWS D1.5 2002 requirements.

The Caltrans QA Inspector performed (VT) examinations of the above mentioned appear to be in conformance with AWS D1.5 2002 requirements.
