Contract #: 04-0120F4Cty: SF/ALA Rte: 80 PM: 13.2/13.9File #: 69.28**WELDING INSPECTION REPORT****Resident Engineer:** Pursell, Gary**Address:** 333 Burma Road**City:** Oakland, CA 94607**Report No:** WIR-000493**Date Inspected:** 21-Sep-2007**Project Name:** SAS Superstructure**OSM Arrival Time:** 1400**Prime Contractor:** American Bridge/Fluor Enterprises, a JV**OSM Departure Time:** 2300**Contractor:** Zhenhua Port Machinery Company, Ltd (ZPMC), Changxing Island **Location:** Changxing Island**CWI Name:** Lujian Ping**CWI Present:** Yes No**Inspected CWI report:** Yes No N/A**Rod Oven in Use:** Yes No N/A**Electrode to specification:** Yes No N/A**Weld Procedures Followed:** Yes No N/A**Qualified Welders:** Yes No N/A**Verified Joint Fit-up:** Yes No N/A**Approved Drawings:** Yes No N/A**Approved WPS:** Yes No N/A**Delayed / Cancelled:** Yes No N/A**Bridge No:** 34-0006**Component:** 114 D,E**Summary of Items Observed:**

Caltrans Quality Assurance (QA) Inspector, Larry Viars was present to observe the welding of the Caltrans Mock-up #77.00 and #114.00, for the San Francisco Oakland bay Self Anchored Suspension Bridge, at Zhenhua Port Machinery Company (ZPMC) facility on Changxi

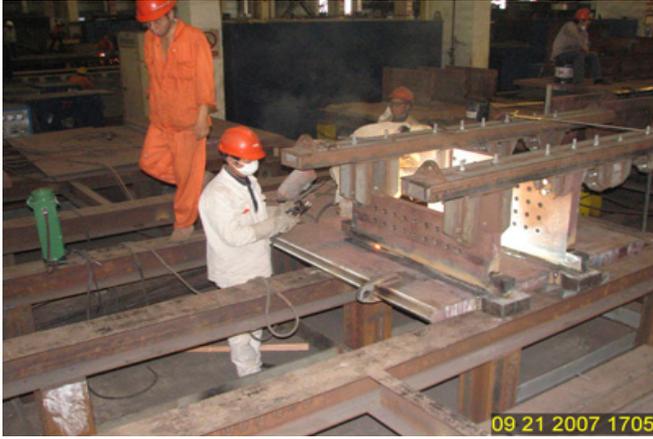
Caltrans QA Inspector observed ZPMC QC nondestructive technician, Mr. Lujian Ping monitoring welding operations of Mock-up 114.00 Skin D sub assembly MA113 stiffener plate root pass of weld #8. Preheating of excavation areas on mock-up 114.00 MA101 stiffener welds and #114 mock-up Skin D MA110 weld #1 filler passes were in progress. QA inspector Viars recorded the following welding variables of #114 Mock-up Skin D sub assembly MA113 weld #8 root pass. Amperage 330, Voltage 30.4 with a travel speed of 307 mm/min.

The Caltrans QA Inspector monitored welding operations of #114.00 Skin D and E. Caltrans QA Inspector observed that the welding operations appeared to be in general conformance with AWS D1.5 2002 requirements.
