Contract #: 04-0120F4Cty: SF/ALA Rte: 80 PM: 13.2/13.9File #: 69.28**WELDING INSPECTION REPORT****Resident Engineer:** Pursell, Gary**Address:** 333 Burma Road**City:** Oakland, CA 94607**Report No:** WIR-000553**Date Inspected:** 24-Sep-2007**Project Name:** SAS Superstructure**OSM Arrival Time:** 630**Prime Contractor:** American Bridge/Fluor Enterprises, a JV**OSM Departure Time:** 1530**Contractor:** Zhenhua Port Machinery Company, Ltd (ZPMC), Changxing Island **Location:** Shanghai, China**CWI Name:** Ye Yongjun**CWI Present:** Yes No**Inspected CWI report:** Yes No N/A**Rod Oven in Use:** Yes No N/A**Electrode to specification:** Yes No N/A**Weld Procedures Followed:** Yes No N/A**Qualified Welders:** Yes No N/A**Verified Joint Fit-up:** Yes No N/A**Approved Drawings:** Yes No N/A**Approved WPS:** Yes No N/A**Delayed / Cancelled:** Yes No N/A**Bridge No:** 34-0006**Component:** Mock Up**Summary of Items Observed:**

WELDING INSPECTION REPORT

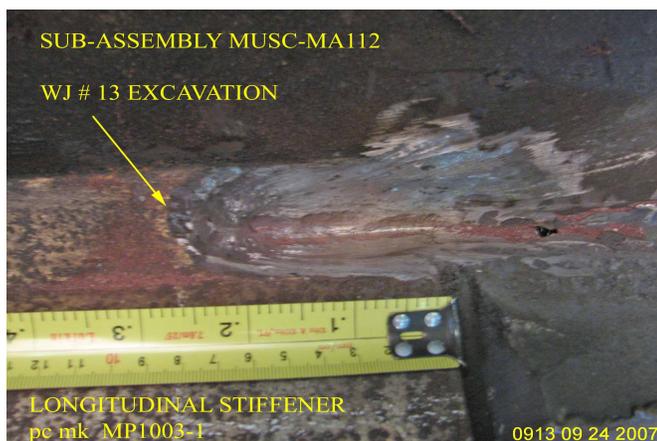
The QA Inspector randomly observed ZPMC Non Destructive Testing Technician Cai Xin Xin, utilizing the Magnetic Particle Testing Method (MT) to examine 1 excavation each in the CJP WJ's numbers 10 and 13 attaching longitudinal stiffeners piece marks MP1003-1 and MP1003-2 to SA MUSC-MA112 Face C (Skin Plate C), prior to performing first time weld repairs. There appeared to be no indications. The attached photograph provides additional detail.

The QA Inspector asked ZPMC QA Representative Shen Xue Jun if he knew what the total length was of the defects found in WJ's 10 and 13, attaching longitudinal stiffeners piece marks MP1003-1 and MP1003-2 to SA MUSC-MA112 Face C (Skin Plate C). Mr. Shen informed the QA Inspector that he did not. The QA Inspector then asked Mr. Shen if he could get a copy of the Ultrasonic Testing Report, and Mr. Shen informed the QA Inspector that he would do so.
