Contract #: 04-0120F4Cty: SF/ALA Rte: 80 PM: 13.2/13.9File #: 69.28**WELDING INSPECTION REPORT****Resident Engineer:** Pursell, Gary**Address:** 333 Burma Road**City:** Oakland, CA 94607**Report No:** WIR-000628**Date Inspected:** 12-Oct-2007**Project Name:** SAS Superstructure**OSM Arrival Time:** 2330**Prime Contractor:** American Bridge/Fluor Enterprises, a JV**OSM Departure Time:** 800**Contractor:** Zhenhua Port Machinery Company, Ltd (ZPMC), Changxing Island **Location:** Shanghai, China

WELDING INSPECTION REPORT

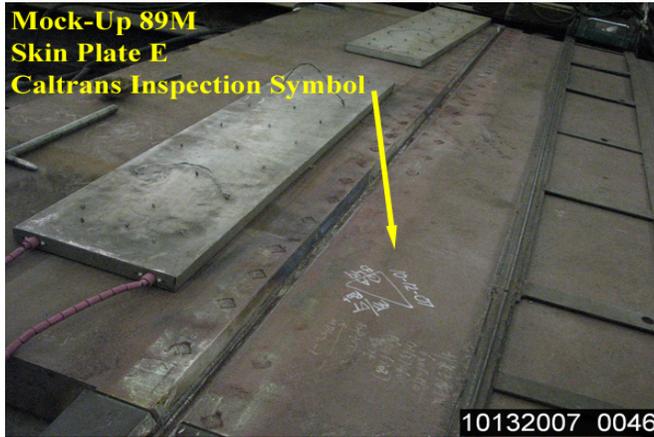
Caltrans QA Inspector witnessed ZPMC QC non-destructive testing technician, Mr. Zhou Danyun perform magnetic particle test (MT) and Visual Test (VT) inspection of the partial joint penetration root weld pass. The location is identified as plate piecemark number mp502 to MA38, weld number 16, outside side. The MT testing appeared to be in general conformance with AWS D1.5 2002 requirements.

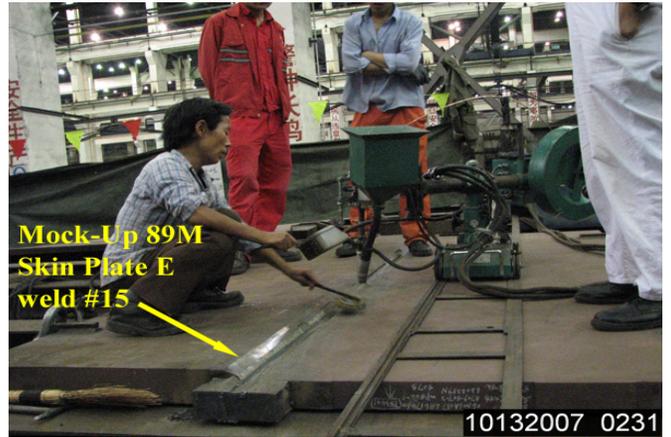
Caltrans QA Inspector performed MT and VT inspection of the root pass weld identified as weld 16. See Caltrans Magnetic Particle Test Report, TL6028, generated on this date for additional information. Following digital picture illustrates Caltrans distinguishing inspection symbol, identifying weld 16, root pass has been VT/MT tested.
