Contract #: 04-0120F4Cty: SF/ALA Rte: 80 PM: 13.2/13.9File #: 69.28**WELDING INSPECTION REPORT****Resident Engineer:** Pursell, Gary**Address:** 333 Burma Road**City:** Oakland, CA 94607**Report No:** WIR-000718**Date Inspected:** 25-Oct-2007**Project Name:** SAS Superstructure**OSM Arrival Time:** 630**Prime Contractor:** American Bridge/Fluor Enterprises, a JV**OSM Departure Time:** 1530**Contractor:** Zhenhua Port Machinery Company, Ltd (ZPMC), Changxing Island **Location:** Changxing Island**CWI Name:** Shai Zhi**CWI Present:** Yes No**Inspected CWI report:** Yes No N/A**Rod Oven in Use:** Yes No N/A**Electrode to specification:** Yes No N/A**Weld Procedures Followed:** Yes No N/A**Qualified Welders:** Yes No N/A**Verified Joint Fit-up:** Yes No N/A**Approved Drawings:** Yes No N/A**Approved WPS:** Yes No N/A**Delayed / Cancelled:** Yes No N/A**Bridge No:** 34-0006**Component:** Mock-up 89 and 114**Summary of Items Observed:**

Caltrans Quality Assurance (QA) Inspector, Larry Viars was present to observe the Welding operations and of the Caltrans Mock-up # 89.00 and Heat Shaping of 77.00, for the San Francisco Oakland Bay Self Anchored Suspension Bridge, at Zhenhua Port Machine

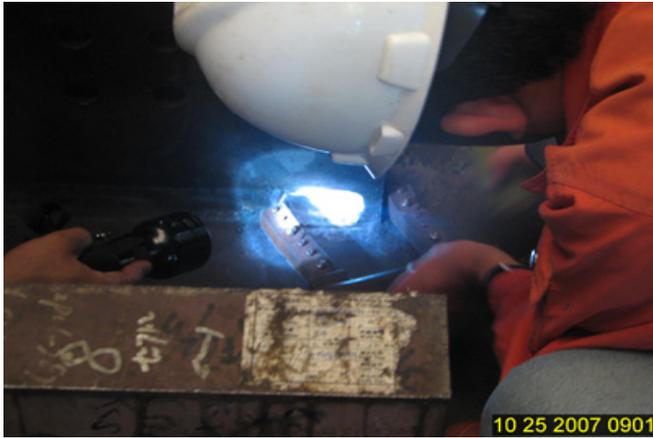
Inspector Viars monitored the MT of Mock-up # 114.00 sub assembly MA111 weld joint # 5 excavation area. ZPMC QC Mr. Cai Xin Xin performed the MT of the excavation area and found the area to be acceptable to AWS D1.5 requirements. The following picture illustrates Mr. Cai Xin Xin performing MT of the above mentioned excavation area.
