Contract #: 04-0120F4Cty: SF/ALA Rte: 80 PM: 13.2/13.9File #: 69.28**WELDING INSPECTION REPORT****Resident Engineer:** Pursell, Gary**Address:** 333 Burma Road**City:** Oakland, CA 94607**Report No:** WIR-000746**Date Inspected:** 23-Oct-2007**Project Name:** SAS Superstructure**OSM Arrival Time:** 630**Prime Contractor:** American Bridge/Fluor Enterprises, a JV**OSM Departure Time:** 1500**Contractor:** Zhenhua Port Machinery Company, Ltd (ZPMC), Changxing Island **Location:** Shanghai, China**CWI Name:** Lee Chan Woo & Sha Zhi**CWI Present:** Yes No**Inspected CWI report:** Yes No N/A**Rod Oven in Use:** Yes No N/A**Electrode to specification:** Yes No N/A**Weld Procedures Followed:** Yes No N/A**Qualified Welders:** Yes No N/A**Verified Joint Fit-up:** Yes No N/A**Approved Drawings:** Yes No N/A**Approved WPS:** Yes No N/A**Delayed / Cancelled:** Yes No N/A**Bridge No:** 34-0006**Component:** Caltrans Mockup**Summary of Items Observed:**

Caltrans Quality Assurance (QA) Inspector, Mike Hasler was present to observe the fit up, welding and related activities associated with the fabricating of Caltrans Mock-up, 77M, 89M, 114M and U-Rib Trial Assembly, for the San Francisco Oakland

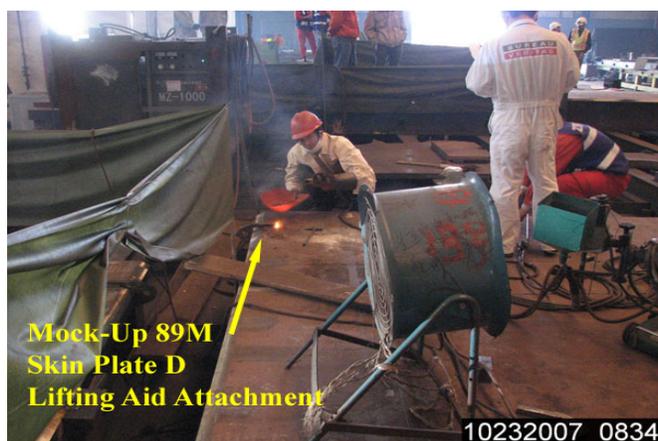
3 Skin Plate D NA NA Work in Progress

Mock-Up 89M, Skin Plate D: Caltrans QA Inspector observed shielded metal arc welding (SMAW) in progress. The welder is observed welding lifting aids to the assembly, identified as MA22-1, piecemark mp509-1 and mp506-1. The welder is observed applying multi-pass fillet welds in the horizontal position. The welder is identified as Mr. Wang Zhonghua, welder stamp 053753. The welder is using welding procedure specification WPS-B-P-2112, Revision 1. Caltrans QA Inspector observed ZPMC Quality Control (QC) Certified Welding Inspector (CWI) Mr. Xu Le feng and Bureau Veritas inspector, Mr. Li Gang monitoring welding activities at the workstation. Caltrans QA Inspector measured current welding parameters at approximately 200 amps and 110 millimeters per minute (mm/min) travel speed. Preheat and interpass temperatures were verified during welding activities. The preheat temperature prior to the start of welding measures more than 110 Celsius (230 degree Fahrenheit) but less than 232 Celsius (450 degrees Fahrenheit) during maximum interpass temperature verification. SMAW consumable is verified and identified as TL-508, classification E7018, specification AWS A5.1, and diameter 5.0 mm (.196 inch). Following digital picture illustrates welding in progress.
