**DEPARTMENT OF TRANSPORTATION**

DIVISION OF ENGINEERING SERVICES

Contract #: 04-0120F4Cty: SF/ALA Rte: 80 PM: 13.2/13.9File #: 69.28**WELDING INSPECTION REPORT****Resident Engineer:** Pursell, Gary**Address:** 333 Burma Road**City:** Oakland, CA 94607**Report No:** WIR-003962**Date Inspected:** 03-Sep-2008**Project Name:** SAS Superstructure**OSM Arrival Time:** 700**Prime Contractor:** American Bridge/Fluor Enterprises, a JV**OSM Departure Time:** 1530**Contractor:** Zhenhua Port Machinery Company, Ltd (ZPMC), Changxing Island **Location:** Shanghai, China**CWI Name:** See below**CWI Present:** Yes No**Inspected CWI report:** Yes No N/A**Rod Oven in Use:** Yes No N/A**Electrode to specification:** Yes No N/A**Weld Procedures Followed:** Yes No N/A**Qualified Welders:** Yes No N/A**Verified Joint Fit-up:** Yes No N/A**Approved Drawings:** Yes No N/A**Approved WPS:** Yes No N/A**Delayed / Cancelled:** Yes No N/A**Bridge No:** 34-0006**Component:** Tower & OBG**Summary of Items Observed:**

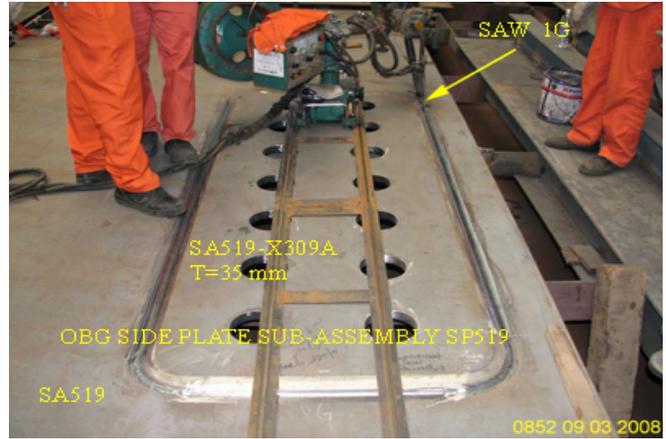
The QA Inspector randomly observed ZPMC welder Wu Zhibin ID Number 049804, utilizing the Submerged Arc Welding (SAW) Process in the 1G (Flat Groove) Position with ZPMC WPS WPS-B-T-2221--B-L2c-S-2, to weld 35 millimeter (mm) Insert Plate SP519-X309A to Side Plate SP519-001 at WJ 073. The QA Inspector randomly observed ZPMC QC under the supervision of ZPMC CWI Wu Ming Kai, monitoring weld parameters. The QA Inspector also randomly monitored weld parameters and recorded them as follows: 591 amps, 29.8 volts with a travel speed of 465 mm/minute. The weld parameters appeared to comply with contract requirements. The attached photograph provides additional detail.
