Quality Assurance and Source Inspection

Contract #: 04-0120F4Cty: SF/ALA Rte: 80 PM: 13.2/13.9File #: 69.28**WELDING INSPECTION REPORT****Resident Engineer:** Pursell, Gary**Address:** 333 Burma Road**City:** Oakland, CA 94607**Report No:** WIR-003967**Date Inspected:** 14-Sep-2008**Project Name:** SAS Superstructure**OSM Arrival Time:** 700**Prime Contractor:** American Bridge/Fluor Enterprises, a JV**OSM Departure Time:** 1530**Contractor:** Zhenhua Port Machinery Company, Ltd (ZPMC), Changxing Island **Location:** Shanghai, China

OBG Bay 4:

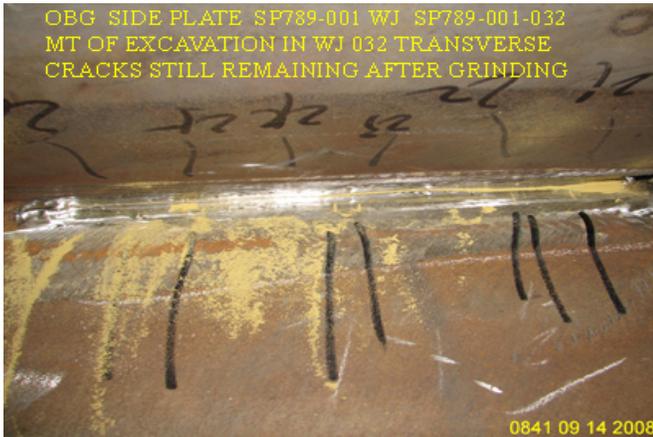
The QA Inspector randomly observed ZPMC Non-Destructive Testing (NDT) Technician Zhao Dongyun utilizing the MT Method to examine 100% of the excavations of WJ's 026/027, 028/029 and 032/033 on SP407A (B-CWR158); WJ 032 on SP788A and SP789; WJ's 001 through 006 on DP633A and DP629A; WJ 055 on SP406 and WJ's 032, 033, 035, 038 and 041 on SP403A. There appeared to be no indications in the excavations on SP403A, SP406, DP629, SP788A and DP633A; and these items were accepted by Mr. Zhao. There were remaining indications observed by ZPMC QC in the excavations on SP407A and SP789. The QA Inspector observed that these excavations were inaccessible with an angle grinder and that a pencil grinder would have to be utilized to remove the indications in the excavations in SP407A and SP789. The attached photograph provides additional detail.
