Contract #: 04-0120F4Cty: SF/ALA Rte: 80 PM: 13.2/13.9File #: 69.28**WELDING INSPECTION REPORT****Resident Engineer:** Pursell, Gary**Address:** 333 Burma Road**City:** Oakland, CA 94607**Report No:** WIR-003978**Date Inspected:** 21-Sep-2008**Project Name:** SAS Superstructure**OSM Arrival Time:** 2100**Prime Contractor:** American Bridge/Fluor Enterprises, a JV**OSM Departure Time:** 730**Contractor:** Zhenhua Port Machinery Company, Ltd (ZPMC), Changxing Island **Location:** Shanghai, China**CWI Name:** Li Yan Hua**CWI Present:** Yes No**Inspected CWI report:** Yes No N/A**Rod Oven in Use:** Yes No N/A**Electrode to specification:** Yes No N/A**Weld Procedures Followed:** Yes No N/A**Qualified Welders:** Yes No N/A**Verified Joint Fit-up:** Yes No N/A**Approved Drawings:** Yes No N/A**Approved WPS:** Yes No N/A**Delayed / Cancelled:** Yes No N/A**Bridge No:** 34-0006**Component:** OBG and Tower**Summary of Items Observed:**

Caltrans Quality Assurance (QA) Inspector, Larry Viars was present to observe the Production Monitoring Test (PMT) for Orthotropic Box Girder (OBG) Deck panels and fabrication of Tower components, for the San Francisco Oakland Bay Self Anchored Suspension Br

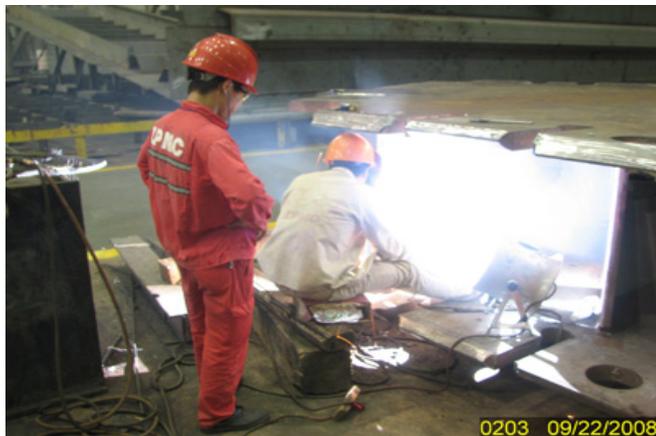
being performed on the 33 meter Diaphragm web plate piece mark P832. The web plate was fabricated 20 mm shorter than the required length. ZPMC welder stencil #053753 was observed depositing Shielded Metal Arc Welding (SMAW) passes in the vertical position to build up the base metal required dimension. ZPMC did not complete welding during the night shift. Welding appeared be conformance with the posted Welding Procedure Specification WPS-485-SMAW-3G (3F)-Repair. Please see the attached photo below of ZPMC performing the above mentioned welding.
