**DEPARTMENT OF TRANSPORTATION**

Contract #: 04-0120F4Cty: SF/ALA Rte: 80 PM: 13.2/13.9File #: 69.28**WELDING INSPECTION REPORT****Resident Engineer:** Pursell, Gary**Address:** 333 Burma Road**City:** Oakland, CA 94607**Report No:** WIR-004077**Date Inspected:** 27-Sep-2008**Project Name:** SAS Superstructure**OSM Arrival Time:** 1400**Prime Contractor:** American Bridge/Fluor Enterprises, a JV**OSM Departure Time:** 2300**Contractor:** Zhenhua Port Machinery Company, Ltd (ZPMC), Changxing Island **Location:** Shanghai China

Tower shop bay 2

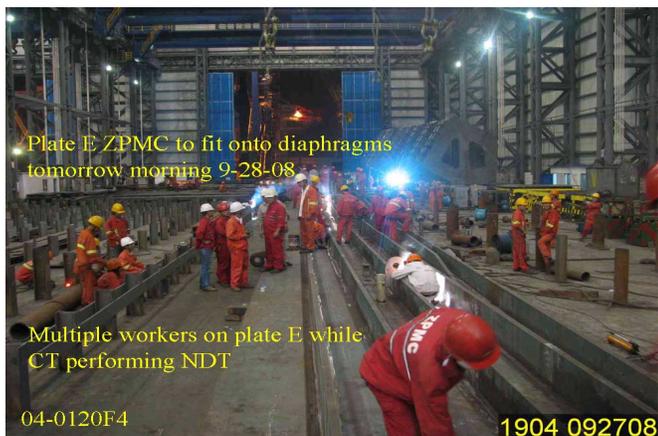
This QA inspector received notification from ZPMC for non destructive testing of stiffener to skin plate for the East skin E plate. This QA Inspector performed UT verification for weld numbers ESDF1-SA227 A/H-66, 67 A/B, ESD1-SA216 F/K-7 A/B after ZPMC had performed their testing and accepted these areas. At the time of the QA review the welds appeared to within compliance of the contract documents. Also noted is the conversation this QA inspector had with Ken Zhang in regards to the marking of the UT areas where ZPMC had performed their UT and the installation of this skin plate and the delay for Caltrans to do their QA review. Swing Shift received verbal notification from ABF representative that ZPMC would be installing skin plate E on the east tower section lift 1 tomorrow 9-28-08. Caltrans QA Inspectors received the NDT notification at 1330 for ZPMC to perform UT testing on the stiffener to skin plate weldments. Swing shift arrived in the shop to perform the QA verification and observed that none of the weldments had been marked by ZPMC for UT completion (either accept or reject) after lunch Caltrans QA met with Ken Zhang of ZPMC and was informed that ZPMC had completed the UT except for 4 welds but was not going to mark these locations until all welds were completed. Caltrans QA explained to ZPMC Ken Zhang that with ZPMC not marking each location after it was completed they were delaying Caltrans QA review (at the time of conversation it was a 2 hr delay due to no markings from ZPMC) from performing the QA verification. ZPMC Mr. Zhang understood this situation and said he would inform the UT technicians to mark the weldment as they complete them. Mr. Zhang was also informed that as ZPMC wants to install this component tomorrow morning and due to ZPMC finishing the UT late in the shift that Caltrans has 24 hrs to have access to these welds as outlined on their NDT request sheet note 4. He then replied that may not happen. ZPMC was also working on the skin plate E which with welding grinding and heating could prolong Caltrans availability to have access to the weldments for safety. See digital photo below for amount of personnel at this location.
