Contract #: 04-0120F4Cty: SF/ALA Rte: 80 PM: 13.2/13.9File #: 69.28**WELDING INSPECTION REPORT****Resident Engineer:** Pursell, Gary**Address:** 333 Burma Road**City:** Oakland, CA 94607**Report No:** WIR-004123**Date Inspected:** 13-Oct-2008**Project Name:** SAS Superstructure**OSM Arrival Time:** 2230**Prime Contractor:** American Bridge/Fluor Enterprises, a JV**OSM Departure Time:** 730**Contractor:** Zhenhua Port Machinery Company, Ltd (ZPMC), Changxing Island **Location:** Shanghai, China**CWI Name:** An Qing Liang**CWI Present:** Yes No**Inspected CWI report:** Yes No N/A**Rod Oven in Use:** Yes No N/A**Electrode to specification:** Yes No N/A**Weld Procedures Followed:** Yes No N/A**Qualified Welders:** Yes No N/A**Verified Joint Fit-up:** Yes No N/A**Approved Drawings:** Yes No N/A**Approved WPS:** Yes No N/A**Delayed / Cancelled:** Yes No N/A**Bridge No:** 34-0006**Component:** Tower**Summary of Items Observed:**

Caltrans Quality Assurance (QA) Inspector, Mike Hasler was present to observe the fitup, welding and related activities associated with the fabricating of Caltrans Orthotropic Box Girder (OBG) and Tower, for the San Francisco Oakland Bay Self Anchored Suspension

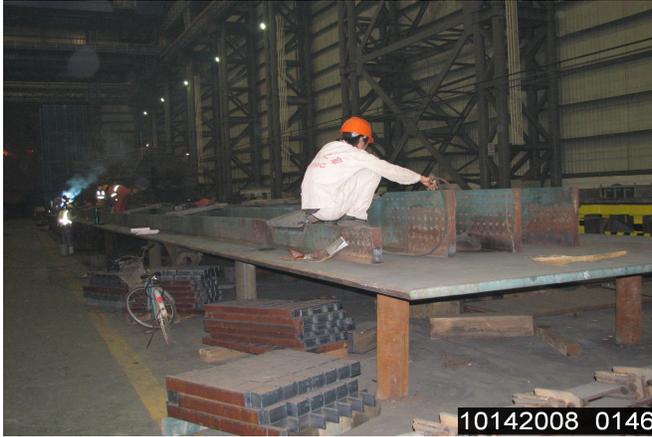
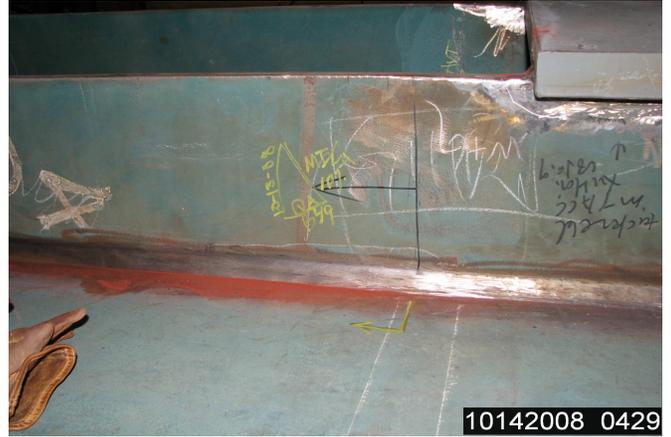
Heavy Shop 1: Caltrans QA inspector performed MT/10% inspection at skin plate "D", longitudinal stiffeners cover pass welds identified as weld ESD1-SA296A/E, 11, 12, 13, 14, 15, 16, 17 and 18. Caltrans QA inspector tested 5 meters at each weld. During Swing Shift, shift change. Mr. Paul Dawson stated, he performed random visual inspection and observed places on the welds for welding pick-ups, and the regrinding of the weld access holes on the longitudinal stiffeners. Mr. Dawson thought that ZPMC might complete this rework and present to Caltrans QA night shift for reinspection. This rework was not completed by ZPMC. ZPMC QA inspector, Mr. Shen Xue Jun informed Caltrans QA inspector that this reinspection of skin plate "D" would be presented to Caltrans at future date for reinspection. The welds MT inspected appeared to be in conformance with the project specifications. See Caltrans Magnetic Particle Test Report (TL-6028) dated October 13, 2008 for additional information. The following digital pictures illustrate tower skin plate "D" subassembly and QAMT inspected weld #11.
