DEPARTMENT OF TRANSPORTATION

Quality Assurance and Source Inspection

Contract #: 04-0120F4Cty: SF/ALA Rte: 80 PM: 13.2/13.9File #: 69.28**WELDING INSPECTION REPORT****Resident Engineer:** Pursell, Gary**Address:** 333 Burma Road**City:** Oakland, CA 94607**Report No:** WIR-004275**Date Inspected:** 23-Oct-2008**Project Name:** SAS Superstructure**OSM Arrival Time:** 1400**Prime Contractor:** American Bridge/Fluor Enterprises, a JV**OSM Departure Time:** 2300**Contractor:** Zhenhua Port Machinery Company, Ltd (ZPMC), Changxing Island **Location:** Shanghai China**CWI Name:** Liu Yang**CWI Present:** Yes No**Inspected CWI report:** Yes No N/A**Rod Oven in Use:** Yes No N/A**Electrode to specification:** Yes No N/A**Weld Procedures Followed:** Yes No N/A**Qualified Welders:** Yes No N/A**Verified Joint Fit-up:** Yes No N/A**Approved Drawings:** Yes No N/A**Approved WPS:** Yes No N/A**Delayed / Cancelled:** Yes No N/A**Bridge No:** 34-0006**Component:** Tower/OBG**Summary of Items Observed:**

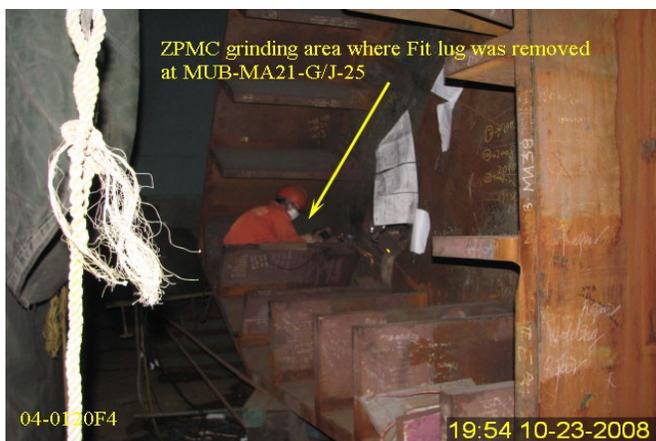
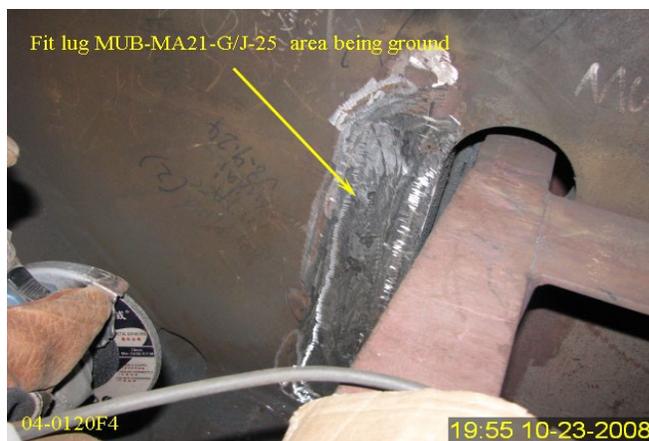
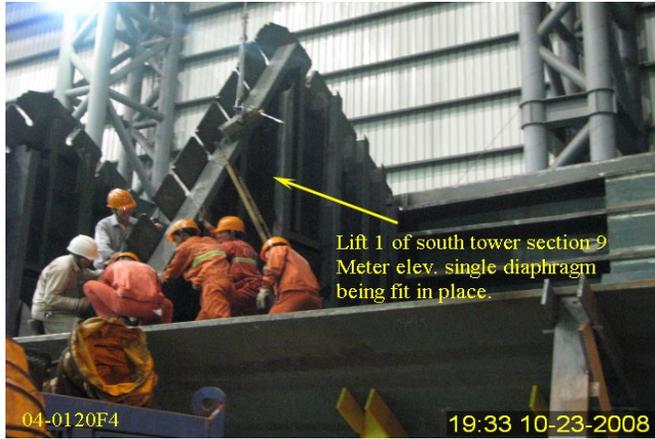
89M Mock up

During his QA random observations it was noted that ZPMC was grinding on the 89M mock up where they had removed the last fit lug trial number MUB-MA21-G/J-25/26. It is unknown at this time why ZPMC has removed this component. The only ZPMC employee that was at this location was the grinding personnel. Below is a digital picture taken at the time this QA inspector first observed the procedure. No information was relayed to Caltrans QA Inspector that ZPMC would be removing the fit lug and for what reason.
