DEPARTMENT OF TRANSPORTATION

Quality Assurance and Source Inspection

Contract #: 04-0120F4Cty: SF/ALA Rte: 80 PM: 13.2/13.9File #: 69.28**WELDING INSPECTION REPORT****Resident Engineer:** Pursell, Gary**Address:** 333 Burma Road**City:** Oakland, CA 94607**Report No:** WIR-004413**Date Inspected:** 21-Oct-2008**Project Name:** SAS Superstructure**OSM Arrival Time:** 700**Prime Contractor:** American Bridge/Fluor Enterprises, a JV**OSM Departure Time:** 1700**Contractor:** Zhenhua Port Machinery Company, Ltd (ZPMC), Changxing Island **Location:** Shanghai, China**CWI Name:** Lie Yun, Peter Shaw**CWI Present:** Yes No**Inspected CWI report:** Yes No N/A**Rod Oven in Use:** Yes No N/A**Electrode to specification:** Yes No N/A**Weld Procedures Followed:** Yes No N/A**Qualified Welders:** Yes No N/A**Verified Joint Fit-up:** Yes No N/A**Approved Drawings:** Yes No N/A**Approved WPS:** Yes No N/A**Delayed / Cancelled:** Yes No N/A**Bridge No:** 34-0006**Component:** OBG**Summary of Items Observed:**

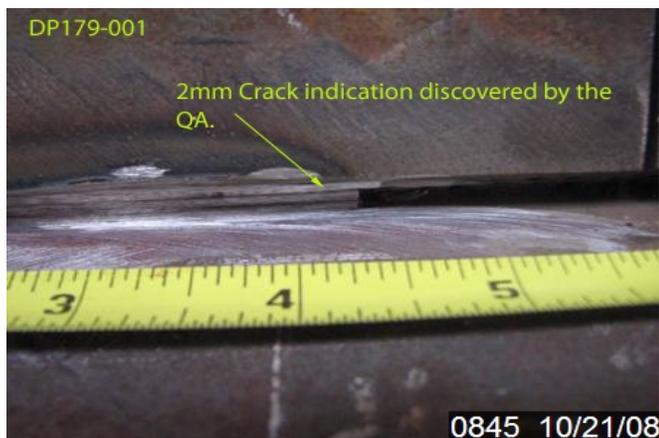
The Quality Assurance Inspector observed ZPMC perform an open root repair on DP050-001. The Quality Assurance Inspector observed ZPMC welder 066239 grind the cracked tack weld area completely open. The QA observed ZPMC perform a preheat on the repair area. When the area was brought up to temperature in accordance with WPS-345-SMAW-2G(2F)-repair ZPMC welder 066239 began welding the open root repair area with the shielded metal arc welding (SMAW) process. The Quality Assurance Inspector observed ZPMC Quality Control perform magnetic particle testing on the root. When the testing was completed, ZPMC welder 066239 completed welding the repair area. American Bridge /Flour Quality Assurance Inspector informed the Quality Assurance Inspector the repaired area will be inspected with ultrasonic testing weld the weld reaches ambient temperature.
