**DEPARTMENT OF TRANSPORTATION**

Contract #: 04-0120F4Cty: SF/ALA Rte: 80 PM: 13.2/13.9File #: 69.28**WELDING INSPECTION REPORT****Resident Engineer:** Pursell, Gary**Address:** 333 Burma Road**City:** Oakland, CA 94607**Report No:** WIR-004459**Date Inspected:** 29-Oct-2008**Project Name:** SAS Superstructure**OSM Arrival Time:** 630**Prime Contractor:** American Bridge/Fluor Enterprises, a JV**OSM Departure Time:** 1730**Contractor:** Zhenhua Port Machinery Company, Ltd (ZPMC), Changxing Island **Location:** Shanghai, China**CWI Name:** Hu Wei Qing**CWI Present:** Yes No**Inspected CWI report:** Yes No N/A**Rod Oven in Use:** Yes No N/A**Electrode to specification:** Yes No N/A**Weld Procedures Followed:** Yes No N/A**Qualified Welders:** Yes No N/A**Verified Joint Fit-up:** Yes No N/A**Approved Drawings:** Yes No N/A**Approved WPS:** Yes No N/A**Delayed / Cancelled:** Yes No N/A**Bridge No:** 34-0006**Component:** OBG & Tower**Summary of Items Observed:**

## WELDING INSPECTION REPORT

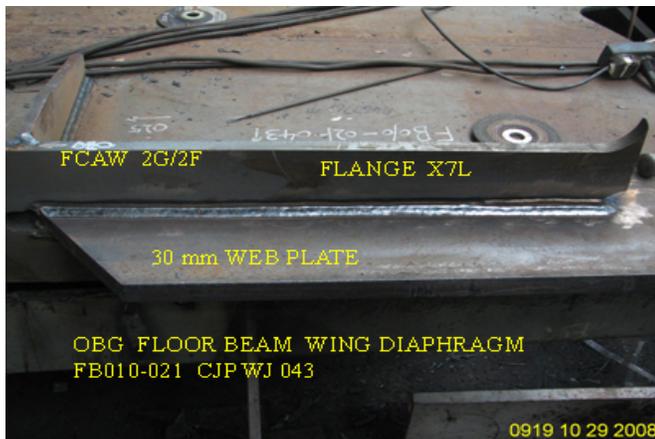
The QA Inspector performed a 10% final Visual (VT) and MT verification on the cover pass of all the welds on Floor Beam Wing Diaphragms FB015-028 (Side B), FB016-028 (Side B). There appeared to be no indications the QA Inspector accepted all of the above listed welds. The attached photograph provides additional detail.
