DEPARTMENT OF TRANSPORTATION

Quality Assurance and Source Inspection

Contract #: 04-0120F4Cty: SF/ALA Rte: 80 PM: 13.2/13.9File #: 69.28**WELDING INSPECTION REPORT****Resident Engineer:** Pursell, Gary**Address:** 333 Burma Road**City:** Oakland, CA 94607**Report No:** WIR-004744**Date Inspected:** 20-Nov-2008**Project Name:** SAS Superstructure**OSM Arrival Time:** 2230**Prime Contractor:** American Bridge/Fluor Enterprises, a JV**OSM Departure Time:** 730**Contractor:** Zhenhua Port Machinery Company, Ltd (ZPMC), Changxing Island **Location:** Shanghai, China**CWI Name:****CWI Present:**

Bridge No: 34-0006**Component:** OBG**Summary of Items Observed:**

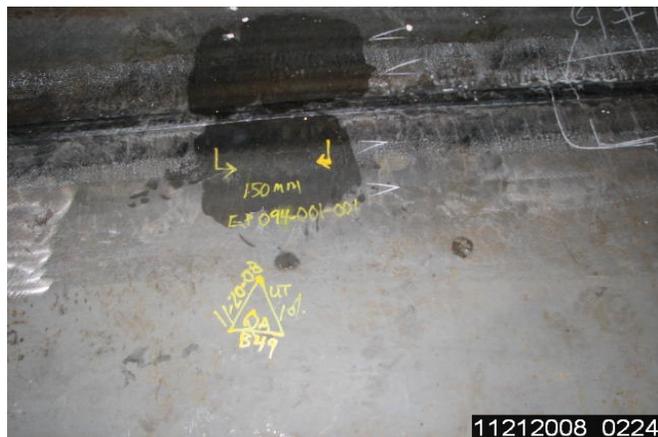
Bay 3: Caltrans QA inspector performed ultrasonic test (UT) inspection per Caltrans swing-shift inspector, Mr. Ken Riley. The subassemblies are identified as OBG edge plate EP094-001, weld 001, edge plate EP062-001, weld 001

and side plate SP466-001, weld 041 complete joint penetration (CJP) plate splice welds. Caltrans QA inspector observed that the welds have been UT inspected and accepted by ZPMC QC. Caltrans QA-UT coverage was approximately 10%. The welds appeared to be in conformance with the project specifications. See Caltrans Ultrasonic Test Report (TL-6027) dated, November 20, 2008 for additional information. The following digital picture illustrates inspected FB094-001-001 weld.
