Contract #: 04-0120F4Cty: SF/ALA Rte: 80 PM: 13.2/13.9File #: 69.28**WELDING INSPECTION REPORT****Resident Engineer:** Pursell, Gary**Address:** 333 Burma Road**City:** Oakland, CA 94607**Report No:** WIR-004772**Date Inspected:** 14-Nov-2008**Project Name:** SAS Superstructure**OSM Arrival Time:** 1330**Prime Contractor:** American Bridge/Fluor Enterprises, a JV**OSM Departure Time:** 2230**Contractor:** Zhenhua Port Machinery Company, Ltd (ZPMC), Changxing Island **Location:** Shanghai, China**CWI Name:** Mr. Shen Fu Yon**CWI Present:** Yes No**Inspected CWI report:** Yes No N/A**Rod Oven in Use:** Yes No N/A**Electrode to specification:** Yes No N/A**Weld Procedures Followed:** Yes No N/A**Qualified Welders:** Yes No N/A**Verified Joint Fit-up:** Yes No N/A**Approved Drawings:** Yes No N/A**Approved WPS:** Yes No N/A**Delayed / Cancelled:** Yes No N/A**Bridge No:** 34-0006**Component:** OBG Fabrication**Summary of Items Observed:**

Caltrans Quality Assurance (QA) Inspector, Mr. Paul Dawson, arrived on site at the Zhenhua Port Machinery Company (ZPMC) facility at Changxing Island, in Shanghai, China, for the purpose of monitoring welding and fabrication of the San Francisco / Oa

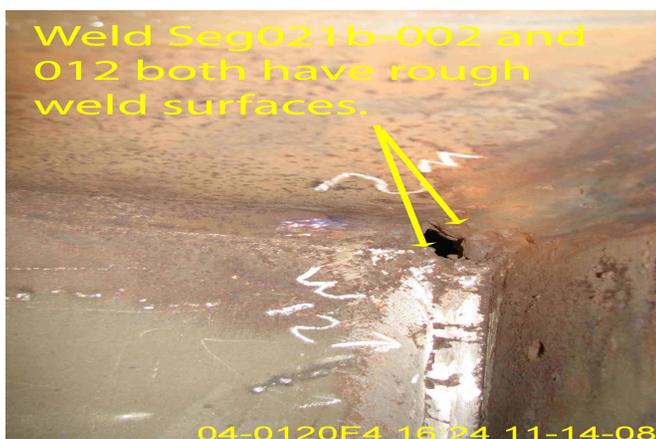
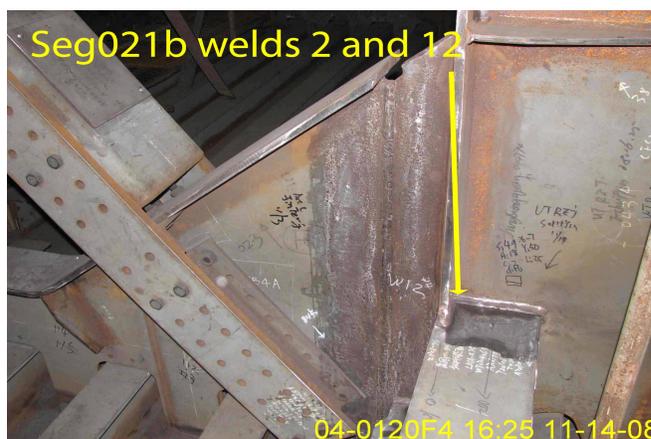
This QA Inspector performed random final visual and ultrasonic (UT) inspections of welds SEG021b-003, 004, 012, 022, SEG021c-004, 005, 012, 023 and 031. ZPMC ultrasonic inspectors have marked the following welds as being ultrasonically rejected: SEG021c-002, 005, 023, 031, SEG021b-002, 003 and 022. The QA Inspector observed all of the welds listed above appear to have never been identified as being visually accepted by ZPMC QC personnel and most of the weld terminations are in the 'as welded' condition and have never been ground smooth. One of the welds also has welding slag covering portions of the weld surface. The welds that were ultrasonically inspected by this QA Inspector appear to comply with AWS D1.5 UT requirements. The QA Inspector asked ABF representatives Mr. Bao Qian and Li Hao for assistance in obtaining a ZPMC CWI to visually inspect these welds and instead of obtaining a CWI they had ZPMC QC representatives Mr. Shang Lin and Mr. John Wu Shigao look at the two welds. Neither of these QC representatives were AWS CWI Inspectors. The QA Inspector asked both the ABF representatives and both of the QC Inspectors to have the CWI that is responsible for the welding in OBG Assembly bay #2 come and look at the visually rejected welds. Neither of the QC Inspectors knew which CWI is responsible for the welding inspection activities in OBG Assembly Bay #2, and after a 30 minute wait ZPMC CWI Mr. Shen Fu Yon arrived and he agreed the weld terminations need to be

ground. See the photographs below for additional information.
