DEPARTMENT OF TRANSPORTATION

Quality Assurance and Source Inspection

Contract #: 04-0120F4Cty: SF/ALA Rte: 80 PM: 13.2/13.9File #: 70.28**WELDING INSPECTION REPORT****Resident Engineer:** Pursell, Gary**Address:** 333 Burma Road**City:** Oakland, CA 94607**Report No:** WIR-005094**Date Inspected:** 17-Dec-2008**Project Name:** SAS Superstructure**OSM Arrival Time:** 830**Prime Contractor:** American Bridge/Fluor Enterprises, a JV**OSM Departure Time:** 1830**Contractor:** Japan Steel Works**Location:** Muroran, Japan**CWI Name:** Chung Kuan**CWI Present:** Yes No**Inspected CWI report:** Yes No N/A**Rod Oven in Use:** Yes No N/A**Electrode to specification:** Yes No N/A**Weld Procedures Followed:** Yes No N/A**Qualified Welders:** Yes No N/A**Verified Joint Fit-up:** Yes No N/A**Approved Drawings:** Yes No N/A**Approved WPS:** Yes No N/A**Delayed / Cancelled:** Yes No N/A**Bridge No:** 34-0006**Component:** Tower, Jacking and Deviation Saddles**Summary of Items Observed:**

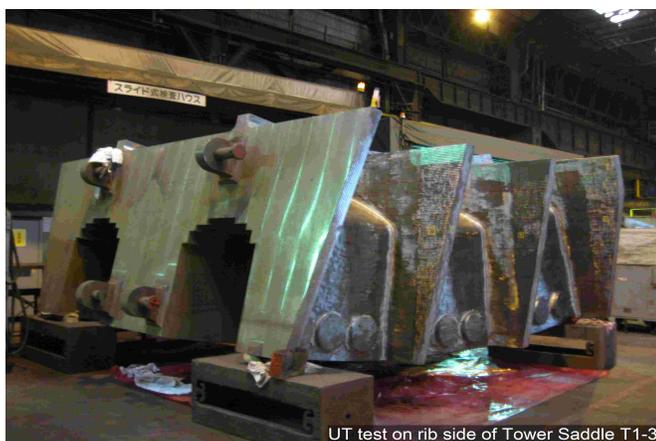
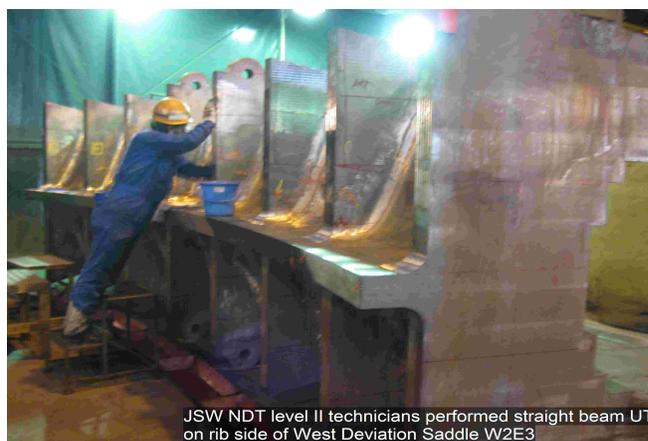
West Deviation Saddle W2E3 and Tower Saddle T1-3: Caltrans QA observed Nikko Inspection Service (NIS) NDT level II technicians performed straight beam UT test on rib side of West Deviation Saddle W2E3 and rib side of Tower Saddle T1-3 (See photo). The metrical of saddle segment is casing Gr. 415 (ASTM A148M G. 620-415) with has a thickness form 150mm to 500mm and both saddle test surface have been Magnetic Particle Test (MT) prior UT test. First, a 500mm range was calibrated on a Krautkramer Branson USM 3 “A scan” tube display instrument, a straight beam method has be applied to test UT test and the search unit is a 24mm x 2 MHz single transducer applied a source of compression waves, and penetrated into segment W2E3 and T1-3 for discontinuity scanning. The distance and sensitivity of straight beam is calibrated with the 3.0mm and 6.4mm diameter FBH reference block and an additional test reference blocks made by same casting metrical. The liquid glycerin is used to couple the search unit to the test surface. Based on Caltrans observation, no discrepancies were noted. The UT test for both saddle will be continue to 2nd shift. The JSW Mr. Kon informed to Caltrans QAI that UT test will schedule to Monday, Dec-22-08.
