DEPARTMENT OF TRANSPORTATION

Quality Assurance and Source Inspection

Contract #: 04-0120F4Cty: SF/ALA Rte: 80 PM: 13.2/13.9File #: 70.28**WELDING INSPECTION REPORT****Resident Engineer:** Pursell, Gary**Address:** 333 Burma Road**City:** Oakland, CA 94607**Report No:** WIR-005234**Date Inspected:** 15-Jan-2009**Project Name:** SAS Superstructure**Prime Contractor:** American Bridge/Fluor Enterprises, a JV**Contractor:** Japan Steel Works**OSM Arrival Time:** 830**OSM Departure Time:** 1830**Location:** Muroran, Japan**CWI Name:** Chung Kuan**CWI Present:** Yes No**Inspected CWI report:** Yes No N/A**Rod Oven in Use:** Yes No N/A**Electrode to specification:** Yes No N/A**Weld Procedures Followed:** Yes No N/A**Qualified Welders:** Yes No N/A**Verified Joint Fit-up:** Yes No N/A**Approved Drawings:** Yes No N/A**Approved WPS:** Yes No N/A**Delayed / Cancelled:** Yes No N/A**Bridge No:** 34-0006**Component:** Tower, Jacking and Deviation Saddles**Summary of Items Observed:**

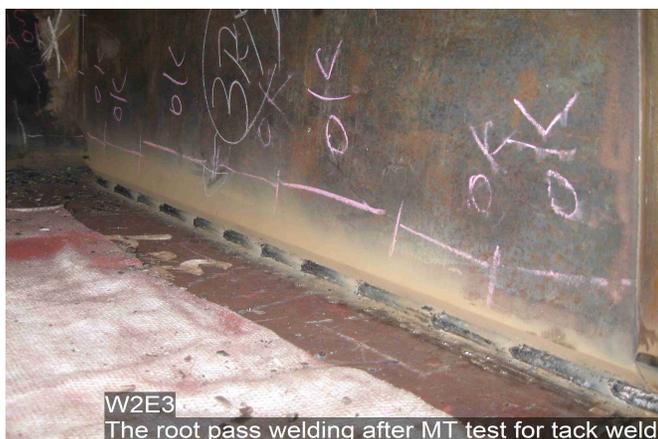
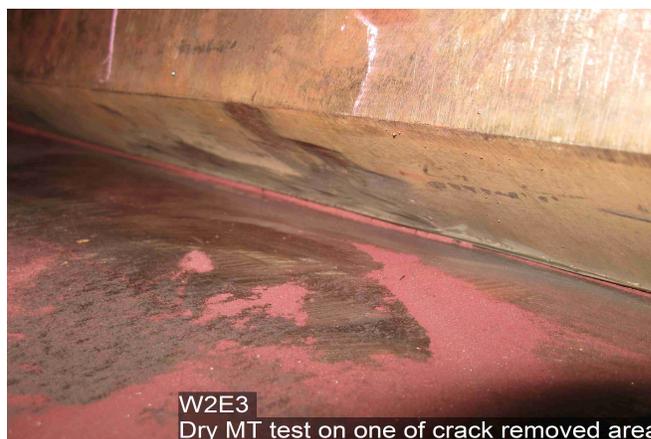
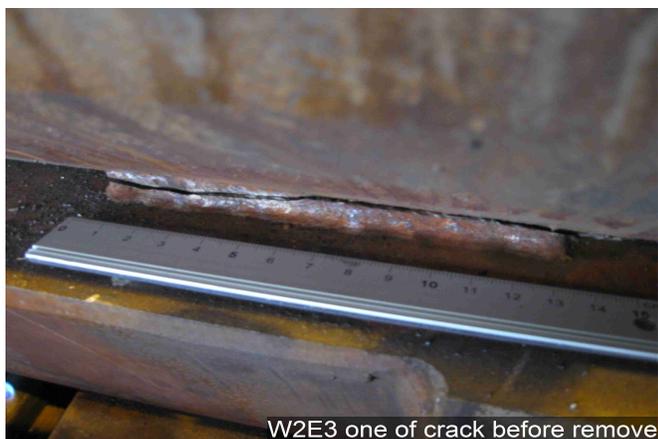
W2E3 West Deviation Saddle Steel Structure: Caltrans QAI representative, CWI Mr. Chung Kuan and NIS NDT level II technician performed VT and dry MT testing on longitudinal and transverse cracks which caused from metal shrinkage and located on horizontal tack welds during fit up process. The horizontal tack welds used are tie in rib plates and stem plate to base plate. The horizontal tack welds on welds E3Y-3L, E3Y-7L, E3Y-13L, E3Y-15L, E3Y-8L and E3Y-14L have been accepted by NIS, CWI and Caltrans after the VT and dry MT test. A total of 10 cracks on tack welds have been found on weld# E3Y-5L, E3Y-15L, E3Y-6L and E3Y-16L after MT test. All the cracks have been removed by grinding. The crack remove areas have re-examined by dry MT test. After MT test completion, Caltrans QAI observed three JSW welders performed SMAW root pass welding. The SMAW root pass welding surface also has been MT test after welding. The proper filler metal used for SMAW is Hoballoy 9018-M with 5mm diameter electrode made by Hobart Brothers, USA. The entire steel structure remains at a preheat temperature of 110 C degree during the crack removal and root pass welding. The root pass welding process and parameters have been monitored and recorded by CWI inspector Mr. Chung Kuan. Based on Caltrans observation, no discrepancies were noted.
