DEPARTMENT OF TRANSPORTATION

Quality Assurance and Source Inspection

Contract #: 04-0120F4Cty: SF/ALA Rte: 80 PM: 13.2/13.9File #: 70.28**WELDING INSPECTION REPORT****Resident Engineer:** Pursell, Gary**Address:** 333 Burma Road**City:** Oakland, CA 94607**Report No:** WIR-005252**Date Inspected:** 29-Jan-2009**Project Name:** SAS Superstructure**OSM Arrival Time:** 730**Prime Contractor:** American Bridge/Fluor Enterprises, a JV**OSM Departure Time:** 1645**Contractor:** Japan Steel Works**Location:** Muroan, Japan**CWI Name:** Makhmud Ashadi**CWI Present:** Yes No**Inspected CWI report:** Yes No N/A**Rod Oven in Use:** Yes No N/A**Electrode to specification:** Yes No N/A**Weld Procedures Followed:** Yes No N/A**Qualified Welders:** Yes No N/A**Verified Joint Fit-up:** Yes No N/A**Approved Drawings:** Yes No N/A**Approved WPS:** Yes No N/A**Delayed / Cancelled:** Yes No N/A**Bridge No:** 34-0006**Component:** Tower, Jacking and Deviation Saddles**Summary of Items Observed:**

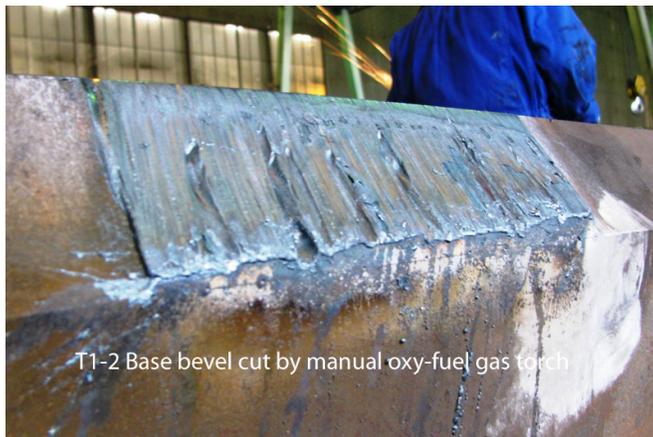
The QA inspector observed JSW personnel continue removing excess material for temporary bracing from the top of rib plates in preparation for fit up to the casting section. The excess material was removed using the manual oxygen-fuel gas method. The QA inspector noted that AWS D1.5-2002 paragraph 3.2.2 requires prior engineer's approval for manual cutting. This issue was brought to the attention of assistant structural materials representative Jay Dorst. See digital images below.

T1-2 Base bevel cut by manual oxy-fuel gas torch

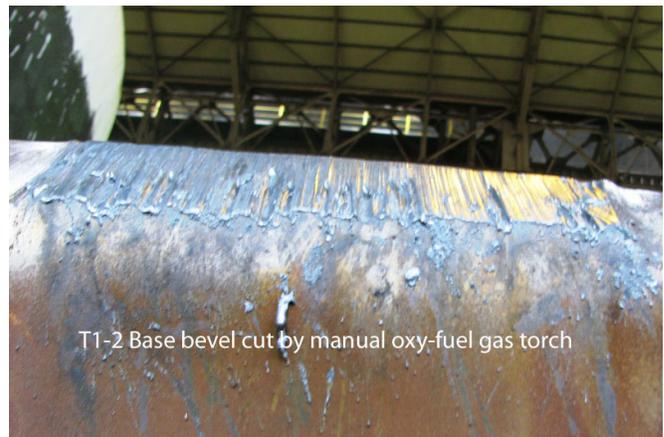
T1-2 Base bevel cut by manual oxy-fuel gas torch
