Contract #: 04-0120F4Cty: SF/ALA Rte: 80 PM: 13.2/13.9File #: 70.28**WELDING INSPECTION REPORT****Resident Engineer:** Pursell, Gary**Address:** 333 Burma Road**City:** Oakland, CA 94607**Report No:** WIR-005405**Date Inspected:** 10-Feb-2009**Project Name:** SAS Superstructure**OSM Arrival Time:** 830**Prime Contractor:** American Bridge/Fluor Enterprises, a JV**OSM Departure Time:** 1700**Contractor:** Japan Steel Works**Location:** Muroran, Japan**CWI Name:** Chung Kuan**CWI Present:** Yes No**Inspected CWI report:** Yes No N/A**Rod Oven in Use:** Yes No N/A**Electrode to specification:** Yes No N/A**Weld Procedures Followed:** Yes No N/A**Qualified Welders:** Yes No N/A**Verified Joint Fit-up:** Yes No N/A**Approved Drawings:** Yes No N/A**Approved WPS:** Yes No N/A**Delayed / Cancelled:** Yes No N/A**Bridge No:** 34-0006**Component:** Tower, Jacking and Deviation saddles**Summary of Items Observed:**

Steel Structure Welding Shop:

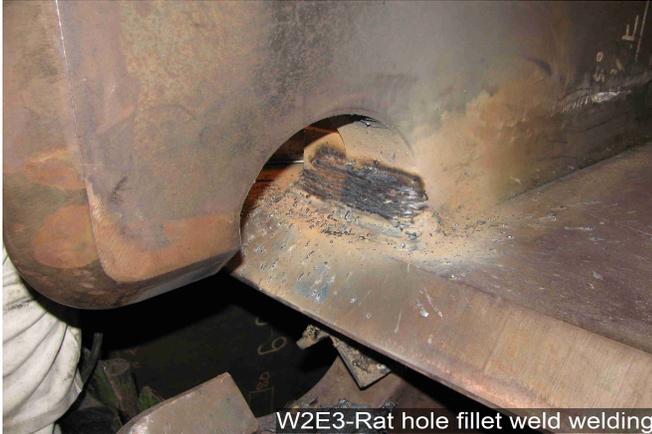
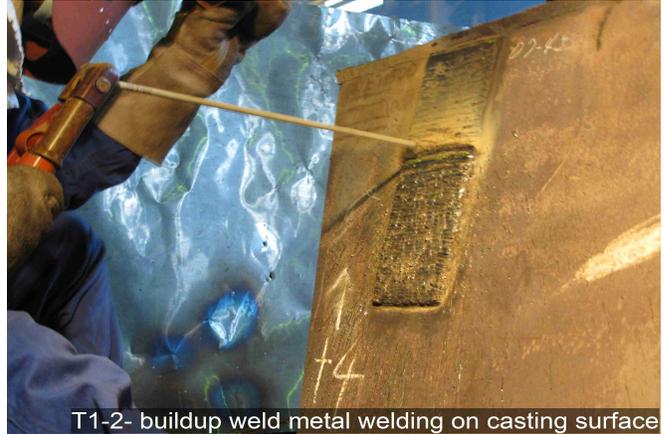
W2E3 West Deviation Saddle Steel Structure: Caltrans Quality Assurance Inspector (QAI) representative observed Japan Steel Works (JSW) welders perform FCAW fillet weld process on weld access holes on rib plates 3-8, 3-10 and 3-12 of W2E3 west deviation saddle. The filler metal and shield gas used for FCAW is Hoballoy wire TM-95K2, 1.6 diameter with 100% C02. The entire welding zone has been preheated to a minimum 110C prior welding. The FCAW welding process and parameters have been monitored and recorded by CWI inspector Mr. Chung Kuan. Based on Caltrans QA observation, the FCAW fillet weld welding operation appeared to be in general compliance with requirements of AWS D1.5 2002 and Caltrans contract documents.

W2E2 West Deviation Saddle Casting and Steel Structure Joint Section: Caltrans QAI representative observed JSW welders perform grinding processes on one side of stem plate weld E2S-2U of W2E2 west deviation saddle and steel portion. The purpose of the grinding is for dry MT test. Based on Caltrans observation, no discrepancies were noted.

T1-2 Tower Saddle Casting: Caltrans QAI representative observed two welders perform SMAW buildup weld metal welding on few casting area surfaces. The buildup weld metal is for the temporary reinforcement supply structure. The buildup metal welding utilizing the SMAW process was conducted by welders in the vertical up position (3G). A 6mm height weld metal has been welded on surfaces. The proper filler metal used for SMAW is LB52A (E7016) with 5mm diameter electrode made by Kobe, Japan. The SMAW welding process and parameters have been Caltrans approved per WPS SJ-3012-5. Based on Caltrans QA observation, the SMAW welding operation appeared to be in general compliance with requirements of AWS D1.5 2002 and Caltrans
