Contract #: 04-0120F4Cty: SF/ALA Rte: 80 PM: 13.2/13.9File #: 69.28**WELDING INSPECTION REPORT****Resident Engineer:** Pursell, Gary**Address:** 333 Burma Road**City:** Oakland, CA 94607**Report No:** WIR-005415**Date Inspected:** 22-Jan-2009**Project Name:** SAS Superstructure**OSM Arrival Time:** 700**Prime Contractor:** American Bridge/Fluor Enterprises, a JV**OSM Departure Time:** 1900**Contractor:** Zhenhua Port Machinery Company, Ltd (ZPMC), Changxing Island **Location:** Shanghai, China**CWI Name:** Shi Lei**CWI Present:** Yes No**Inspected CWI report:** Yes No N/A**Rod Oven in Use:** Yes No N/A**Electrode to specification:** Yes No N/A**Weld Procedures Followed:** Yes No N/A**Qualified Welders:** Yes No N/A**Verified Joint Fit-up:** Yes No N/A**Approved Drawings:** Yes No N/A**Approved WPS:** Yes No N/A**Delayed / Cancelled:** Yes No N/A**Bridge No:** 34-0006**Component:** OBG segments**Summary of Items Observed:**

OBG outside assembly (OBG segment 3AW)

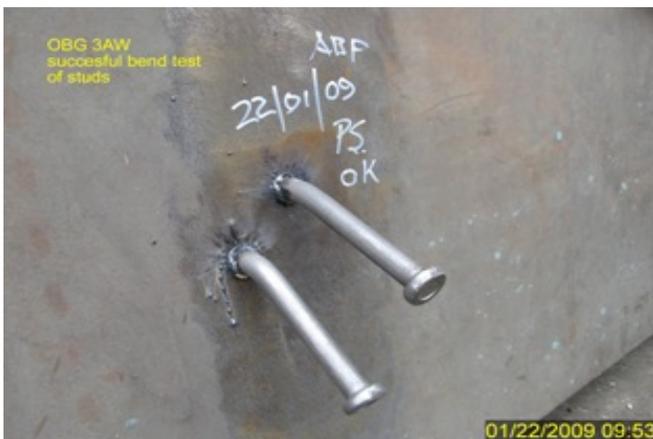
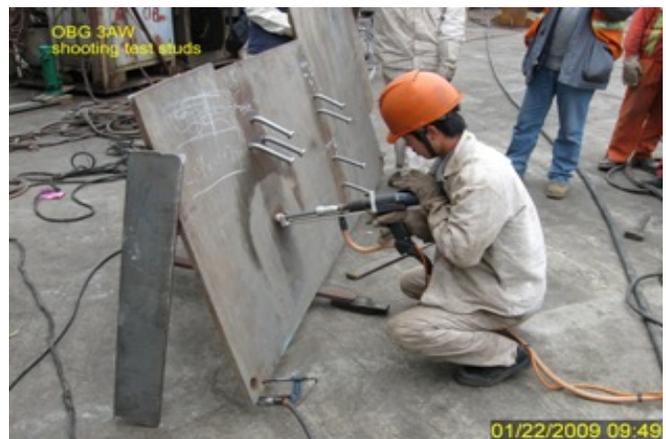
This QA observed ZPMC qualified welding personnel identified as Mr. Ni Lei Jiang (037723) perform SMAW Weld Repair on weld joint identified as SSD12-PP022-232. ZPMC QC identified Mr. Yang Diang was present to monitor the weld repair process. The welding parameters as measured using QC's calibrated instruments appeared to be in general compliance with weld repair report #B-WR1970 and WPS-345-SMAW-4G-(4F)-FCM-repair as referenced on the repair report.

This QA observed ZPMC and ABF personnel perform the daily stud welding test for the above mentioned OBG segment. The test performed appeared to be in compliance with AWS D1.5 2002 and the contract documents. After the completion of the test QA observed ZPMC welding personnel commence welding the studs on the applicable edge plate on this segment.

This QA observed ZPMC qualified welding personnel identified as Mr. Feng Hua Jun (066258) perform SMAW weld repair on weld joint identified as SEG-025-030. ZPMC QC identified Mr. Wang Wei Ming was present to monitor the weld repair process. The welding parameters as measured using QC's calibrated instruments appeared to be in general compliance with WPS-345-SMAW-4G-(4F)-FCM-repair.
