DEPARTMENT OF TRANSPORTATION

Quality Assurance and Source Inspection

Contract #: 04-0120F4Cty: SF/ALA Rte: 80 PM: 13.2/13.9File #: 13.28**WELDING INSPECTION REPORT****Resident Engineer:** Pursell, Gary**Address:** 333 Burma Road**City:** Oakland, CA 94607**Report No:** WIR-005502**Date Inspected:** 24-Feb-2009**Project Name:** SAS Superstructure**OSM Arrival Time:** 630**Prime Contractor:** American Bridge/Fluor Enterprises, a JV**OSM Departure Time:** 1600**Contractor:** Oregon Iron Works Clackamas, Or.**Location:** Clackamas, Oregon**CWI Name:** See below**CWI Present:** Yes No**Inspected CWI report:** Yes No N/A**Rod Oven in Use:** Yes No N/A**Electrode to specification:** Yes No N/A**Weld Procedures Followed:** Yes No N/A**Qualified Welders:** Yes No N/A**Verified Joint Fit-up:** Yes No N/A**Approved Drawings:** Yes No N/A**Approved WPS:** Yes No N/A**Delayed / Cancelled:** Yes No N/A**Bridge No:** 34-0006**Component:** Hinge K Pipe Beams**Summary of Items Observed:**

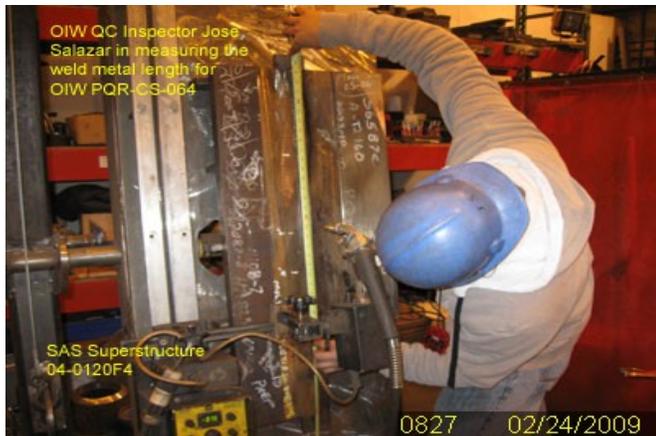
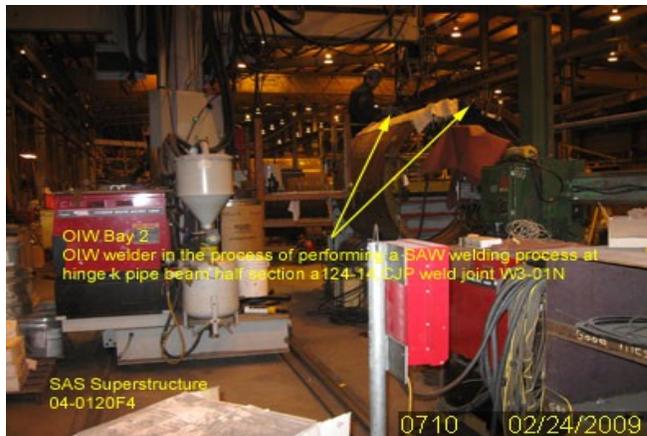
QA Inspector Brannon randomly observed OIW qualified welder Mr. Tim O'Brien ID#O6 groove welding a hinge k pipe beam fuse section a124-14 (HPS 485 W). The complete joint penetration (CJP) weld is identified as weld joint #W3-01N. Mr. O'Brien was observed welding in the 1G (flat) position utilizing submerged arc welding (SAW) process with a 2.4mm diameter electrode, filler metal brand Lincoln Electric LA85 class F9A4-Eni5-G-H2.

The following digital photograph below illustrates observation of the activities being performed.
