Contract #: 04-0120F4Cty: SF/ALA Rte: 80 PM: 13.2/13.9File #: 69.28**WELDING INSPECTION REPORT****Resident Engineer:** Pursell, Gary**Address:** 333 Burma Road**City:** Oakland, CA 94607**Report No:** WIR-005577**Date Inspected:** 26-Feb-2009**Project Name:** SAS Superstructure**OSM Arrival Time:** 700**Prime Contractor:** American Bridge/Fluor Enterprises, a JV**OSM Departure Time:** 1900**Contractor:** Zhenhua Port Machinery Company, Ltd (ZPMC), Changxing Island **Location:** Shanghai China**CWI Name:** Chen Chih-Ming**CWI Present:** Yes No**Inspected CWI report:** Yes No N/A**Rod Oven in Use:** Yes No N/A**Electrode to specification:** Yes No N/A**Weld Procedures Followed:** Yes No N/A**Qualified Welders:** Yes No N/A**Verified Joint Fit-up:** Yes No N/A**Approved Drawings:** Yes No N/A**Approved WPS:** Yes No N/A**Delayed / Cancelled:** Yes No N/A**Bridge No:** 34-0006**Component:** OBG segments**Summary of Items Observed:**

OBG assembly bay 14

WELDING INSPECTION REPORT

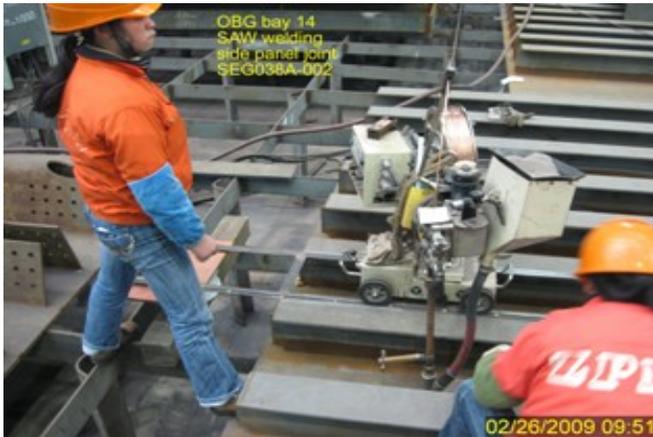
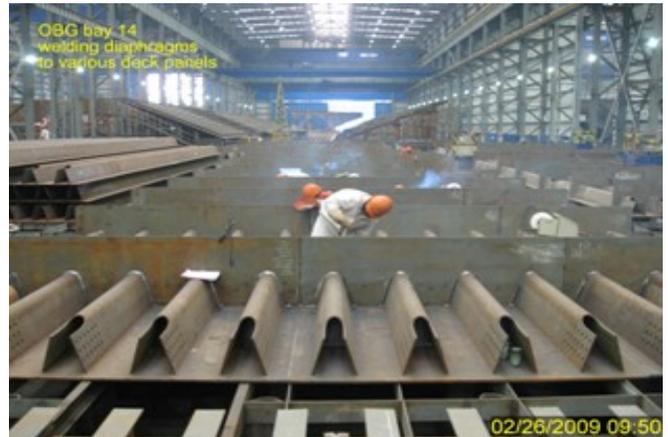
This QA observed ZPMC qualified welding personnel identified as Miss Lu Shiqin (044755) perform SAW welding on weld joint identified as SEG-038A-002 (SP533 to SP573). ZPMC QC identified as Mr. Shen Fuyou was present to monitor the welding process. The welding parameters as measured using QC's calibrated instruments appeared to be in general compliance with WPS-B-T-2221-B-L2c-S-2.

This QA observed ZPMC qualified welding personnel identified as Miss Gao Min (050988) and Mr. Pan Benyong (067601) perform FCAW welding on deck panel U-rib to diaphragm joints. The deck panel were identified as DP-591. ZPMC QC identified as Mr. Shen Fuyou was present to monitor the welding process. The welding parameters as measured using QC's calibrated instruments appeared to be in general compliance with WPS-B-T-2133 and WPS-B-T-2233-Tc-U4b.

This QA observed ZPMC qualified welding personnel identified as Mr. Jia Guangfu (069089) and Mr. Liu Daiquan (066401) perform FCAW welding on deck panel U-rib to diaphragm joints. The deck panel is identified as DP-581. ZPMC QC identified as Mr. Shen Fuyou was present to monitor the welding process. The welding parameters as measured using QC's calibrated instruments appeared to be in general compliance with WPS-B-T-2133 and WPS-B-T-2233-Tc-U4b.

Unless otherwise noted, all work observed on this date appeared to be in general compliance with the applicable contract documents.
