Quality Assurance and Source Inspection

Contract #: 04-0120F4Cty: SF/ALA Rte: 80 PM: 13.2/13.9File #: 69.28**WELDING INSPECTION REPORT****Resident Engineer:** Pursell, Gary**Address:** 333 Burma Road**City:** Oakland, CA 94607**Report No:** WIR-005579**Date Inspected:** 13-Feb-2009**Project Name:** SAS Superstructure**OSM Arrival Time:** 645**Prime Contractor:** American Bridge/Fluor Enterprises, a JV**OSM Departure Time:** 1845**Contractor:** Zhenhua Port Machinery Company, Ltd (ZPMC), Changxing Island **Location:** Shanghai, China**CWI Name:** Shen Fu You**CWI Present:** Yes No**Inspected CWI report:** Yes No N/A**Rod Oven in Use:** Yes No N/A**Electrode to specification:** Yes No N/A**Weld Procedures Followed:** Yes No N/A**Qualified Welders:** Yes No N/A**Verified Joint Fit-up:** Yes No N/A**Approved Drawings:** Yes No N/A**Approved WPS:** Yes No N/A**Delayed / Cancelled:** Yes No N/A**Bridge No:** 34-0006**Component:** OBG**Summary of Items Observed:**

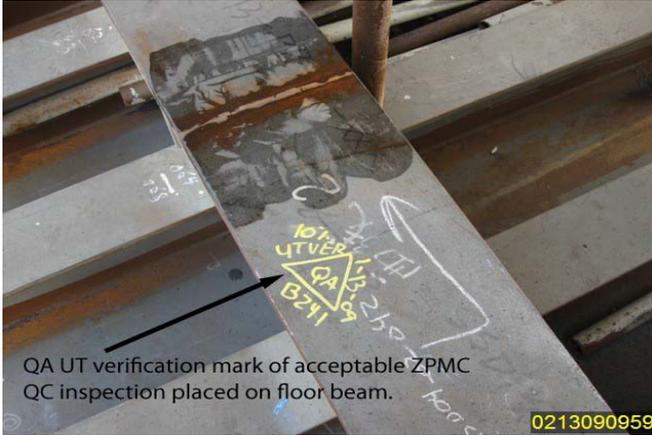
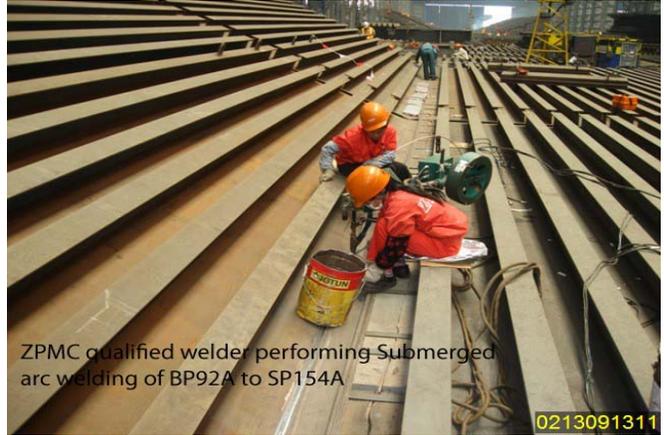
OBG Bay 14 & outside paint shop: QA Inspector performed ultrasonic verification testing of OBG Floor Beams FB004-002-042 flange splice and FB004-002 SSD13 PP24 butt splice Complete Joint Penetration (CJP) butt joints.

Bay 14: QA Inspector randomly observed ZPMC qualified welder ID#045265 welding bottom plate BP92A to side plate SP154A segment 39A. Welder was observed welding in the 1G (flat) position utilizing Submerged Arc Welding (SAW) process. QA Inspector observed the ZPMC QC Inspector Wu Bin verifying welding parameters and pre-heat were in accordance with the Welding Procedure Specification (WPS). QA Inspector with QC Inspector observed parameters as follows: preheat temperature to be at 115°C and measured the welding parameters to be 596 amps, 33.2 volts, a travel speed of 506 mm/min. Welding parameters verified by QA Inspector appear to be in general compliance with the approved WPS-B-T-2221-B-12C-S-2.
