Contract #: 04-0120F4Cty: SF/ALA Rte: 80 PM: 13.2/13.9File #: 13.28**WELDING INSPECTION REPORT****Resident Engineer:** Pursell, Gary**Address:** 333 Burma Road**City:** Oakland, CA 94607**Report No:** WIR-005782**Date Inspected:** 18-Mar-2009**Project Name:** SAS Superstructure**OSM Arrival Time:** 630**Prime Contractor:** American Bridge/Fluor Enterprises, a JV**OSM Departure Time:** 1600**Contractor:** Oregon Iron Works Clackamas, Or.**Location:** Clackamas, Oregon**CWI Name:** See below**CWI Present:** Yes No**Inspected CWI report:** Yes No N/A**Rod Oven in Use:** Yes No N/A**Electrode to specification:** Yes No N/A**Weld Procedures Followed:** Yes No N/A**Qualified Welders:** Yes No N/A**Verified Joint Fit-up:** Yes No N/A**Approved Drawings:** Yes No N/A**Approved WPS:** Yes No N/A**Delayed / Cancelled:** Yes No N/A**Bridge No:** 34-0006**Component:** Hinge K Pipe Beams**Summary of Items Observed:**

On this date, Caltrans Quality Assurance Inspector (QA) Sherri Brannon is present at the Oregon Iron Works, Inc. (OIW) jobsite in Clackamas, Oregon for the purpose of observing fabrication of the Hinge K Pipe Beams.

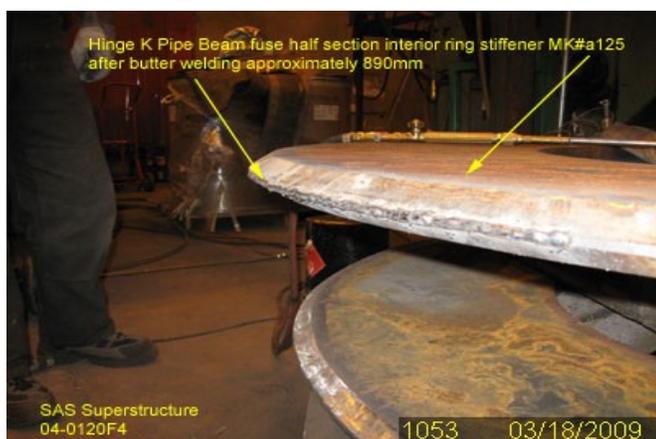
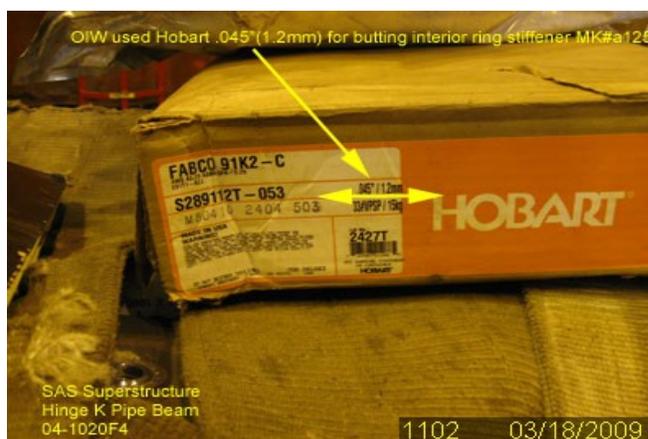
QA Inspector Brannon observed OIW qualified welder Mr. Tim O'Brien ID#O6 build up welding (due to the gap tolerance exceeding 5mm) on interior ring stiffener MK#a125. The interior ring stiffener is to be welded at hinge k pipe beam half fuse section MK#a124-3 weld joint WM3-06 and WM3-07. Mr. O'Brien was observed welding in the 1G (flat) position utilizing flux corded arc welding (FCAW) process with a .045 inch (1.2mm) diameter electrode, filler metal brand Hobart Fabco 91K2-C class 91T1-K2J semi-automatic. Length of the built up welding is approximately 890mm. QA Inspector Brannon questioned QC Inspector Mr. Mike Gregson about OIW using .045 inch (1.2mm) diameter electrode when the welding procedure specification WPS 3046 states Hobart 1/16 inch (1.6mm) diameter electrode. QC Inspector Mr. Gregson choose at this time to stop the built up welding on the interior ring stiffeners. Mr. Gregson stated the Mr. Vern Taute informed him that Hobart does make a .054 inch (1.4mm) diameter electrode but it would need to be a special order but since the electrode is not a standard size that using a .045 inch (1.2mm) diameter electrode that is would be ok to use for the tack welding and building up welding on the interior ring stiffeners. QA Inspector Brannon informed QA Lead Inspector Joe Adame of the above. QA Lead Inspector Joe Adame informed QA Inspector Brannon that Mr. Patrick Lowery stated that OIW has exceeded the welding electrode diameter limitations as listed in Table 5.3 of the AWS D1.5 2002 by decreasing the electrode diameter by more than one standard size. And, that it should be ok to use the .045 inch (1.2mm) diameter electrode for tack welding since the weld metal is consumed by the submerged welding process. QA Inspector Brannon informed QC Mr. Mike Gregson of the above. Welding on the above

The following digital photograph below illustrates observation of the activities being performed.

interior ring stiffener plate was stopped from approximately 11:00 to 1530 hour. QC Inspector Mr. Rob Walters informed QA Inspector Brannon that Welding Repair Report (WRR) Wrr-2244-09 will be submitted for the above build up welding.
