**DEPARTMENT OF TRANSPORTATION**

Contract #: 04-0120F4Cty: SF/ALA Rte: 80 PM: 13.2/13.9File #: 13.28**WELDING INSPECTION REPORT****Resident Engineer:** Pursell, Gary**Address:** 333 Burma Road**City:** Oakland, CA 94607**Report No:** WIR-006016**Date Inspected:** 30-Mar-2009**Project Name:** SAS Superstructure**OSM Arrival Time:** 630**Prime Contractor:** American Bridge/Fluor Enterprises, a JV**OSM Departure Time:** 1600**Contractor:** Oregon Iron Works Clackamas, Or.**Location:** Clackamas, Oregon**CWI Name:** See below**CWI Present:** Yes No**Inspected CWI report:** Yes No N/A**Rod Oven in Use:** Yes No N/A**Electrode to specification:** Yes No N/A**Weld Procedures Followed:** Yes No N/A**Qualified Welders:** Yes No N/A**Verified Joint Fit-up:** Yes No N/A**Approved Drawings:** Yes No N/A**Approved WPS:** Yes No N/A**Delayed / Cancelled:** Yes No N/A**Bridge No:** 34-0006**Component:** Hinge K Pipe Beams**Summary of Items Observed:**

# WELDING INSPECTION REPORT

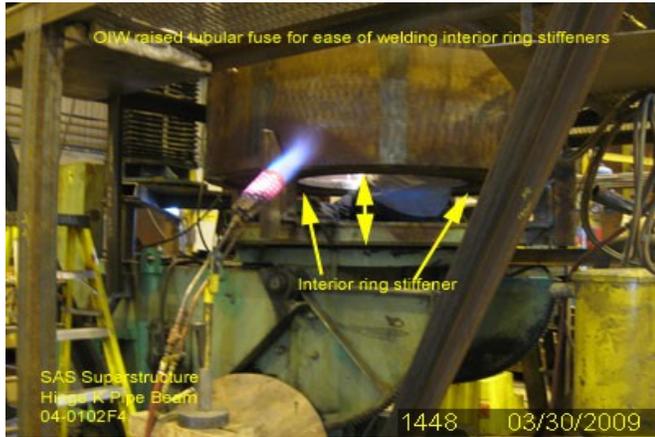
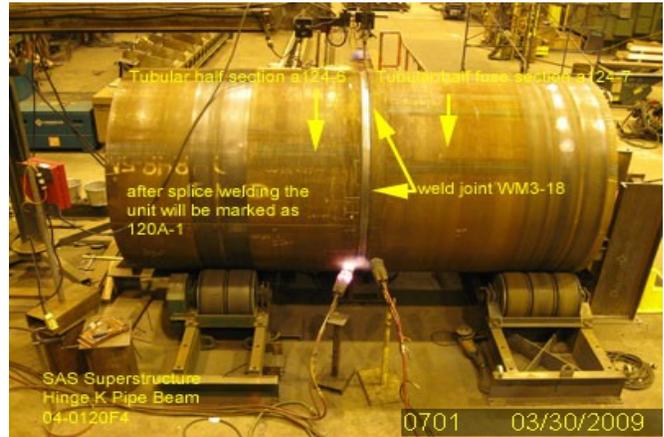
QA Inspector Brannon randomly observed OIW Mr. Tim O'Brien ID#O6 and 1 helper repairing positioner to raise tubular fuse for ease of welding interior ring stiffeners. No welding performed during this shift.

QA Inspector Brannon randomly observed OIW qualified welder Mr. Jerry Sheppard ID#S53 joining hinge K pipe beam fuse half section MK#a124-7 (HPS 485W) to hinge K pipe beam fuse half section MK#a124-6 (HPS 485W) assembly MK#120A-1. The complete joint penetration (CJP) weld is identified as weld joint #WM3-18. Mr. Sheppard was observed welding in the 1G (flat) position utilizing submerged arc welding (SAW) process with a 2.4mm diameter electrode, filler metal brand Lincoln Electric LA85 class F9A4-Eni5-G-H2. QA Inspector Brannon observed the OIW QC CWI Inspector's Mr. Mike Gregson and Mr. Rob Walters verifying that the pre-heat and welding parameters were in accordance with the Welding Procedure Specification (WPS). Welding parameters observed by QA Inspector Brannon appear to be in general compliance with the approved WPS 4020 revision number 0.

The following digital photograph below illustrates observation of the activities being performed.
