Contract #: 04-0120F4Cty: SF/ALA Rte: 80 PM: 13.2/13.9File #: 69.28**WELDING INSPECTION REPORT****Resident Engineer:** Pursell, Gary**Address:** 333 Burma Road**City:** Oakland, CA 94607**Report No:** WIR-006108**Date Inspected:** 27-Mar-2009**Project Name:** SAS Superstructure**OSM Arrival Time:** 645**Prime Contractor:** American Bridge/Fluor Enterprises, a JV**OSM Departure Time:** 1845**Contractor:** Zhenhua Port Machinery Company, Ltd (ZPMC), Changxing Island **Location:** Shanghai, China**CWI Name:** See Below**CWI Present:** Yes No**Inspected CWI report:** Yes No N/A**Rod Oven in Use:** Yes No N/A**Electrode to specification:** Yes No N/A**Weld Procedures Followed:** Yes No N/A**Qualified Welders:** Yes No N/A**Verified Joint Fit-up:** Yes No N/A**Approved Drawings:** Yes No N/A**Approved WPS:** Yes No N/A**Delayed / Cancelled:** Yes No N/A**Bridge No:** 34-0006**Component:** OBG Fabrication**Summary of Items Observed:**

OBG Bay 19

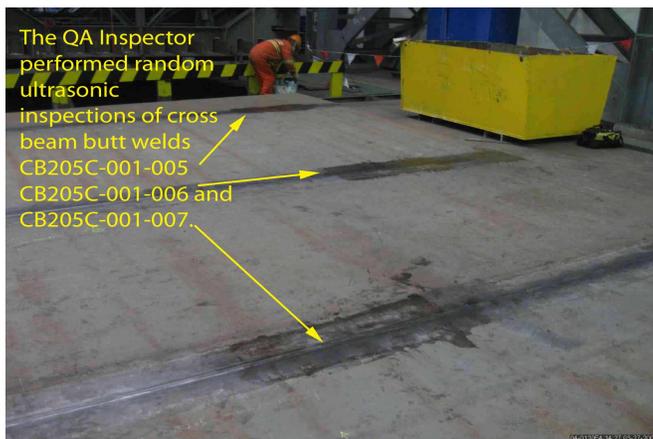
This QA Inspector performed random ultrasonic inspections of approximately 10 percent length of Crossbeam welds CB205C-001-005, CB205C-001-006, CB205C-001-007, CB205C-001-008. These welds had previously been ultrasonically inspected and accepted by ZPMC inspection personnel. The QA Inspector observed the welds that were ultrasonically inspected by this QA Inspector appear to comply with AWS D1.5 UT requirements. For additional information on this inspection see the TL6027 Ultrasonic Test Report and the photograph below.
