DEPARTMENT OF TRANSPORTATION

Contract #: 04-0120F4Cty: SF/ALA Rte: 80 PM: 13.2/13.9File #: 13.28**WELDING INSPECTION REPORT****Resident Engineer:** Pursell, Gary**Address:** 333 Burma Road**City:** Oakland, CA 94607**Report No:** WIR-006343**Date Inspected:** 21-Apr-2009**Project Name:** SAS Superstructure**OSM Arrival Time:** 700**Prime Contractor:** American Bridge/Fluor Enterprises, a JV**OSM Departure Time:** 1530**Contractor:** Oregon Iron Works Clackamas, Or.**Location:** Clackamas, OR**CWI Name:** Mike Gregson, Rob Walters**CWI Present:** Yes No**Inspected CWI report:** Yes No N/A**Rod Oven in Use:** Yes No N/A**Electrode to specification:** Yes No N/A**Weld Procedures Followed:** Yes No N/A**Qualified Welders:** Yes No N/A**Verified Joint Fit-up:** Yes No N/A**Approved Drawings:** Yes No N/A**Approved WPS:** Yes No N/A**Delayed / Cancelled:** Yes No N/A**Bridge No:** 34-0006**Component:** Hinge K Pipe Beams**Summary of Items Observed:**

Hinge-K Pipe Beam Assembly 102A-1: 4/21/09

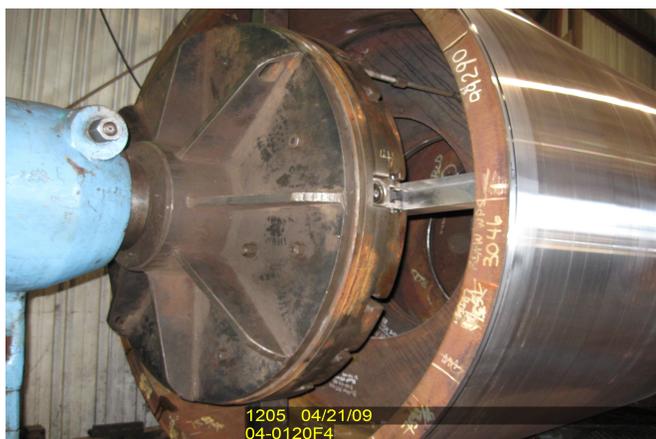
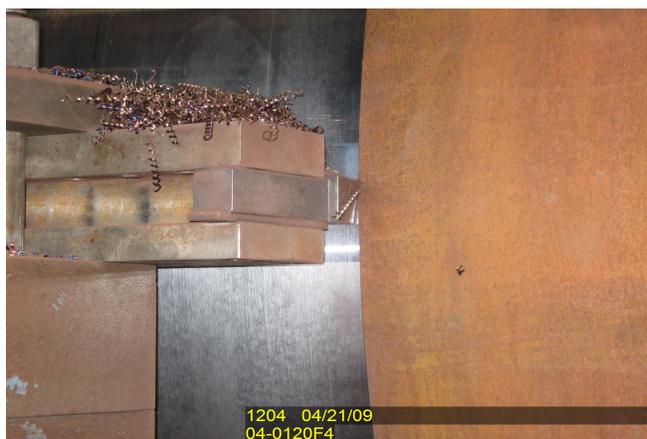
QA Inspector arrived at A & G Machining on this date, to randomly witness the in-process machining of this fuse assembly 120A-1.

QA Inspector noticed the first cut machining pass was complete and the A & G machinist explained that this first pass was cut to a depth of .150" (3.8mm) deep.

A & G Machinist explained that the second cut would also be .150" (3.8mm) deep and a third and final pass would be needed to achieve the desired results of 1903mm in diameter, which is in accordance to the applicable contract requirements. See machining pictures below.....
