Contract #: 04-0120F4Cty: SF/ALA Rte: 80 PM: 13.2/13.9File #: 13.28**WELDING INSPECTION REPORT****Resident Engineer:** Pursell, Gary**Address:** 333 Burma Road**City:** Oakland, CA 94607**Report No:** WIR-006344**Date Inspected:** 22-Apr-2009**Project Name:** SAS Superstructure**OSM Arrival Time:** 700**Prime Contractor:** American Bridge/Fluor Enterprises, a JV**OSM Departure Time:** 1530**Contractor:** Oregon Iron Works Clackamas, Or.**Location:** Clackamas, OR**CWI Name:** Mike Gregson, Rob Walters**CWI Present:** Yes No**Inspected CWI report:** Yes No N/A**Rod Oven in Use:** Yes No N/A**Electrode to specification:** Yes No N/A**Weld Procedures Followed:** Yes No N/A**Qualified Welders:** Yes No N/A**Verified Joint Fit-up:** Yes No N/A**Approved Drawings:** Yes No N/A**Approved WPS:** Yes No N/A**Delayed / Cancelled:** Yes No N/A**Bridge No:** 34-0006**Component:** Hinge K Pipe Beams**Summary of Items Observed:**

## WELDING INSPECTION REPORT

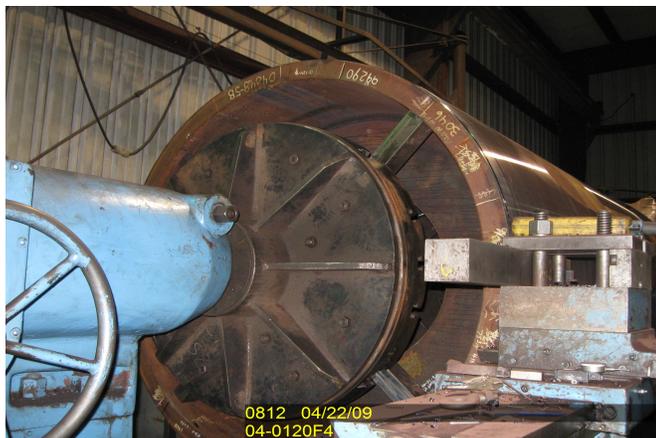
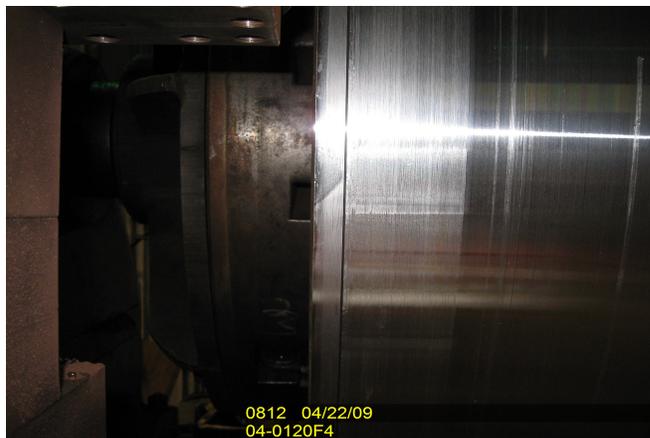
A & G Machinist explained to QA Inspector that no machining would be performed on this fuse assembly 120A-1, on this date and machining would resume on 4/23/09, due to another project that A & G Machining was completing. See idle fuse assembly 120A-1 below.....

QA Inspector Sean Vance performed a verification of material, personnel and equipment involved with the project. The QA Inspector observed at Oregon Iron Works: 6 OIW production personnel and 2 QC Inspectors. The following was observed at A & G Machine: 1 A&G machinist using a horizontal lathe.
