Quality Assurance and Source Inspection

Contract #: 04-0120F4Cty: SF/ALA Rte: 80 PM: 13.2/13.9File #: 13.28**WELDING INSPECTION REPORT****Resident Engineer:** Pursell, Gary**Address:** 333 Burma Road**City:** Oakland, CA 94607**Report No:** WIR-006405**Date Inspected:** 23-Apr-2009**Project Name:** SAS Superstructure**OSM Arrival Time:** 700**Prime Contractor:** American Bridge/Fluor Enterprises, a JV**OSM Departure Time:** 1530**Contractor:** Oregon Iron Works Clackamas, Or.**Location:** Clackamas, OR**CWI Name:** Mike Gregson, Rob Walters**CWI Present:** Yes No**Inspected CWI report:** Yes No N/A**Rod Oven in Use:** Yes No N/A**Electrode to specification:** Yes No N/A**Weld Procedures Followed:** Yes No N/A**Qualified Welders:** Yes No N/A**Verified Joint Fit-up:** Yes No N/A**Approved Drawings:** Yes No N/A**Approved WPS:** Yes No N/A**Delayed / Cancelled:** Yes No N/A**Bridge No:** 34-0006**Component:** Hinge K Pipe Beams**Summary of Items Observed:**

WELDING INSPECTION REPORT

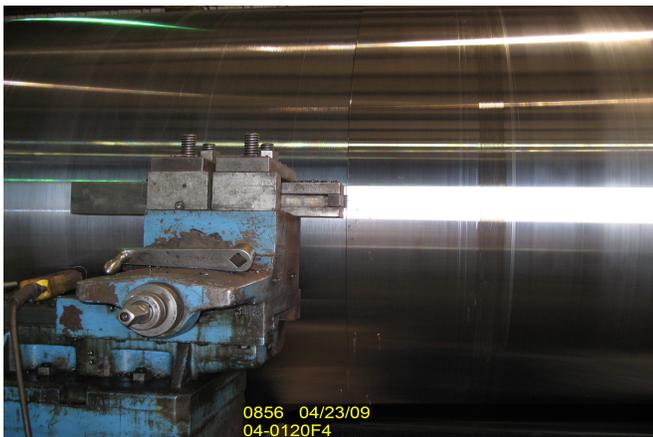
Hinge-K Pipe Beam Fuse Assembly 120A-1: 4/23/09

QA Inspector arrived at A & G Machining on this date, to randomly witness the in-process machining of this fuse assembly 120A-1.

QA Inspector noticed that A & G Machining had completed the first machining cut pass and they were approximately 1/3 complete on second cut pass of .150" (3.8mm). A & G Machining explained to QA Inspector, they should probably be complete with second pass on 4/24/09, sometime in the morning and the third, final pass of .160" (4mm), should start on 4/24/09 and run into Monday. A&G Machining explained to QA Inspector they are targeting to finish with a 1903mm diameter. See attached picture.....
