DEPARTMENT OF TRANSPORTATION

Quality Assurance and Source Inspection

Contract #: 04-0120F4Cty: SF/ALA Rte: 80 PM: 13.2/13.9File #: 69.28**WELDING INSPECTION REPORT****Resident Engineer:** Pursell, Gary**Address:** 333 Burma Road**City:** Oakland, CA 94607**Report No:** WIR-006468**Date Inspected:** 24-Apr-2009**Project Name:** SAS Superstructure**OSM Arrival Time:** 1845**Prime Contractor:** American Bridge/Fluor Enterprises, a JV**OSM Departure Time:** 645**Contractor:** Zhenhua Port Machinery Company, Ltd (ZPMC), Changxing Island **Location:** Shanghai, China**CWI Name:** See Below**CWI Present:** Yes No**Inspected CWI report:** Yes No N/A**Rod Oven in Use:** Yes No N/A**Electrode to specification:** Yes No N/A**Weld Procedures Followed:** Yes No N/A**Qualified Welders:** Yes No N/A**Verified Joint Fit-up:** Yes No N/A**Approved Drawings:** Yes No N/A**Approved WPS:** Yes No N/A**Delayed / Cancelled:** Yes No N/A**Bridge No:** 34-0006**Component:** OBG and Tower Fabrication**Summary of Items Observed:**

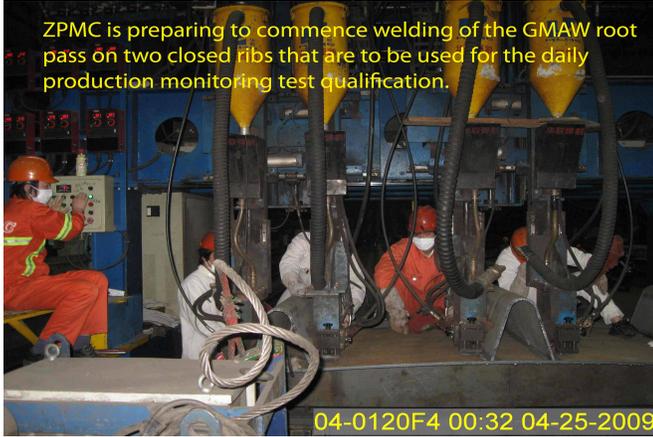
The QA Inspector monitored welding of closed rib Production Monitoring Test representing deck plates DP322-001 and DP294-001 which were welded using one single base plate at approximately 00:35 hours using gantry #1. The QA Inspector observed four ZPMC welders using welding procedure specification WPS-B-T-2342-U1(Urib)-4 using the gas metal arc welding process for the root pass and submerged arc welding process for the cover pass of partial penetration groove welds on two PMT closed rib welds at the same time. ZPMC has multiple welding manipulators attached to a movable gantry that runs on a track along the length of the stiffener plates. The QA Inspector observed a welding travel speed of approximately 533 mm per minute for the root passes and 525 mm per minute for the cover passes. As the welding commences, each of the welders is responsible for one of the welding heads. Welder Mr. Xiang Jie, stencil 59378 completed the root pass of weld #1 with a welding current of approximately 365 amps and 31.4 volts and the cover pass welding current of approximately 680 amps and 24.9 volts. Welder Mr. Jiang Ting Guang, stencil 062265, stencil 201788 completed the root pass of weld #2 with a welding current of approximately 385 amps and 31.2 volts and the cover pass welding current of approximately 690 amps and 24.6 volts. Welder Mr. Xiang Feng, stencil 49416 completed the root pass of weld #3 with a welding current of approximately 365 amps and 30.9 volts and the cover pass welding current of approximately 690 amps and 24.6 volts. Welder Mr. Zhang Shao Hui, stencil 59403 completed the root pass of weld #4 with a welding current of approximately 365 amps and 31.1 volts and the cover pass welding current of approximately 685 amps and 25.0 volts. The QA Inspector performed random visual inspection of the root pass and cover passes and items observed appear to comply with project specifications. Following completion of the welding ZPMC QC CWI Inspector Mr. Sun Bo marked a 500 mm length of the welds as being the areas that are to be representative of this PMT test. The QA Inspector observed ZPMC NDE inspector Mr. Tang Xingshan performing ultrasonic of each of the welds in the areas where Mr. Bo had marked for PMT testing. Following ZPMC's UT acceptance the QA Inspector marked a total of 10 locations where macroetch samples are to be obtained. ZPMC then cut and prepared macroetch samples. ZPMC QC CWI Inspector. Mr. Sun Bo and ABF representative Ms. Lu Yun visually inspected these macroetch samples and documented their acceptance on the ZPMC Production Monitoring Test Plate Inspection Report sheet dated 04-25-2009. The QA Inspector visually inspected each of these macroetch samples and items observed by the QA Inspector appear to comply with project specifications. See the photograph below for additional information.
