DEPARTMENT OF TRANSPORTATION

Contract #: 04-0120F4Cty: SF/ALA Rte: 80 PM: 13.2/13.9File #: 13.28**WELDING INSPECTION REPORT****Resident Engineer:** Pursell, Gary**Address:** 333 Burma Road**City:** Oakland, CA 94607**Report No:** WIR-006546**Date Inspected:** 30-Apr-2009**Project Name:** SAS Superstructure**OSM Arrival Time:** 700**Prime Contractor:** American Bridge/Fluor Enterprises, a JV**OSM Departure Time:** 1530**Contractor:** Oregon Iron Works Clackamas, Or.**Location:** Clackamas, OR**CWI Name:** Mike Gregson, Rob Walters**CWI Present:** Yes No**Inspected CWI report:** Yes No N/A**Rod Oven in Use:** Yes No N/A**Electrode to specification:** Yes No N/A**Weld Procedures Followed:** Yes No N/A**Qualified Welders:** Yes No N/A**Verified Joint Fit-up:** Yes No N/A**Approved Drawings:** Yes No N/A**Approved WPS:** Yes No N/A**Delayed / Cancelled:** Yes No N/A**Bridge No:** 34-0006**Component:** Hinge K Pipe Beams**Summary of Items Observed:**

Hinge-K Pipe Beam Assembly 102A-1: 4/30/09

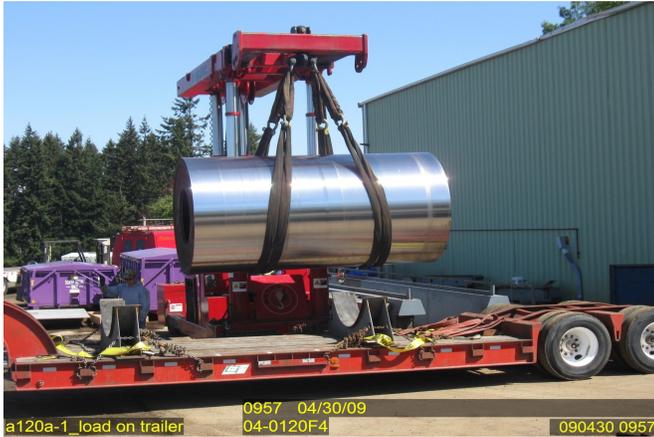
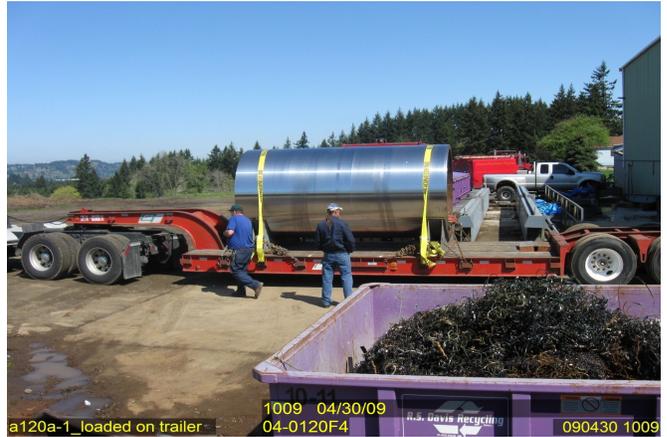
QA Inspector later spoke with QA Lead Inspector Joe Adame and Mr. Adame explained that A&G had loaded this fuse assembly on a flat truck bed, utilizing a crane and two rigging chokers, as shown in pictures below.

QA Inspector Sean Vance performed a verification of personnel at Oregon Iron Works, Inc. and witnessed 6 OIW production personnel and 2 QC. The following was observed at A&G Machining: 1 A&G Machine Supervisor, 2 A&G Workers assisting with fuse change out. 2 Gresham transfer workers (deliver & haul back a fuse). 2 Metro Machinery workers using a hydraulic wheeled lift to offload, and load the fuses.
