DEPARTMENT OF TRANSPORTATION

Quality Assurance and Source Inspection

Contract #: 04-0120F4Cty: SF/ALA Rte: 80 PM: 13.2/13.9File #: 13.28**WELDING INSPECTION REPORT****Resident Engineer:** Pursell, Gary**Address:** 333 Burma Road**City:** Oakland, CA 94607**Report No:** WIR-006885**Date Inspected:** 22-May-2009**Project Name:** SAS Superstructure**OSM Arrival Time:** 700**Prime Contractor:** American Bridge/Fluor Enterprises, a JV**OSM Departure Time:** 1530**Contractor:** Oregon Iron Works Clackamas, Or.**Location:** Clackamas, OR**CWI Name:** Mike Gregson, Rob Walters**CWI Present:** Yes No**Inspected CWI report:** Yes No N/A**Rod Oven in Use:** Yes No N/A**Electrode to specification:** Yes No N/A**Weld Procedures Followed:** Yes No N/A**Qualified Welders:** Yes No N/A**Verified Joint Fit-up:** Yes No N/A**Approved Drawings:** Yes No N/A**Approved WPS:** Yes No N/A**Delayed / Cancelled:** Yes No N/A**Bridge No:** 34-0006**Component:** Hinge K Pipe Beams**Summary of Items Observed:**

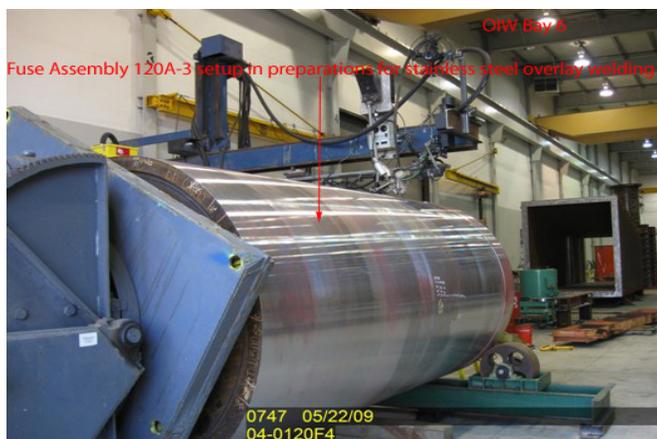
Hinge-K Pipe Beam Fuse Assembly 120A-3: 5/22/09

a124-12 Half Fuse to a124-10 Half Fuse

QA Inspector noticed that OIW production personell had placed this fuse assembly 120A-3 in welding positioner and was setting up welding machine in preparation for the stainless steel overlay welding process. See picture below.

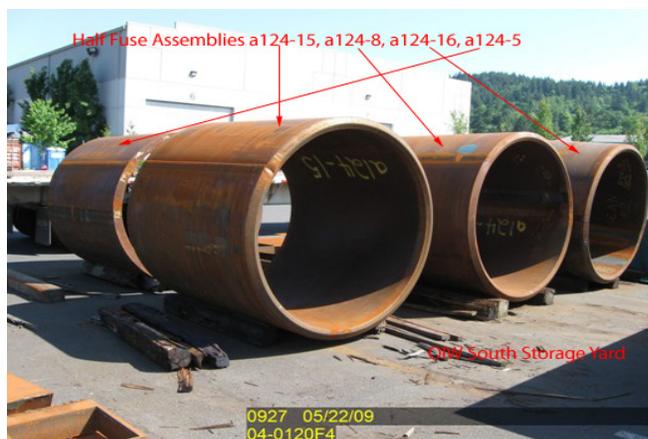
OIW South Storage Yard: 5/22/09

QA Inspector noticed the following half-fuse sub assemblies were sitting idle, pending submerged arc welding on the internal stiffener rings, piece marks identified as a125 & b125: See picture below.

a124-5, a124-8, a124-15 and a124-16.
