Quality Assurance and Source Inspection

Contract #: 04-0120F4Cty: SF/ALA Rte: 80 PM: 13.2/13.9File #: 13.28**WELDING INSPECTION REPORT****Resident Engineer:** Pursell, Gary**Address:** 333 Burma Road**City:** Oakland, CA 94607**Report No:** WIR-007109**Date Inspected:** 10-Jun-2009**Project Name:** SAS Superstructure**OSM Arrival Time:** 2100**Prime Contractor:** American Bridge/Fluor Enterprises, a JV**OSM Departure Time:** 530**Contractor:** Oregon Iron Works Clackamas, Or.**Location:** Clackamas, Oregon**CWI Name:** Steve Barnett, Jon Nickolich**CWI Present:** Yes No**Inspected CWI report:** Yes No N/A**Rod Oven in Use:** Yes No N/A**Electrode to specification:** Yes No N/A**Weld Procedures Followed:** Yes No N/A**Qualified Welders:** Yes No N/A**Verified Joint Fit-up:** Yes No N/A**Approved Drawings:** Yes No N/A**Approved WPS:** Yes No N/A**Delayed / Cancelled:** Yes No N/A**Bridge No:** 34-0006**Component:** Hinge K Pipe Beams**Summary of Items Observed:**

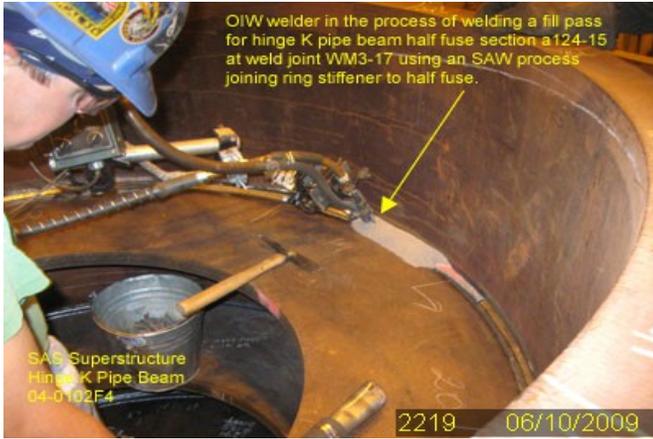
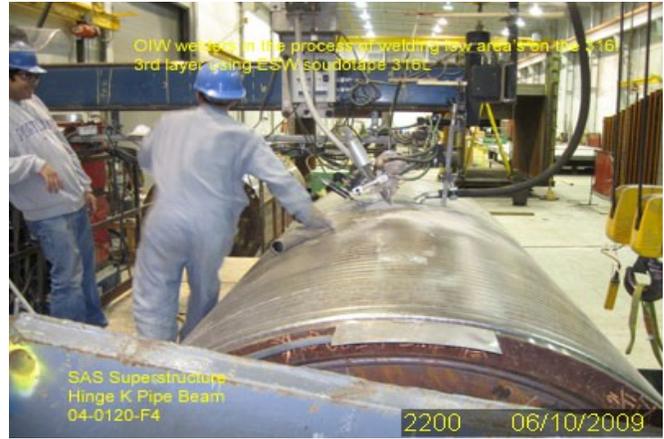
QA Inspector Brannon randomly observed OIW qualified welder's Mr. Mikhail Bannikov ID#B28 and Mr. Liam Bui ID#B10 welding fill pass's joining stiffener ring MK #a125 (HPS 485 W) to hinge K pipe beam half section MK#a124-15 (HPS 485 W). The partial joint penetration (PJP) groove weld is identified as weld joint #WM3-17. Mr. Bannikov was observed welding in the 1G (flat) position utilizing submerged arc welding (SAW) process with a 2.4mm diameter electrode, filler metal brand Lincoln Electric LA85 class F9A4-Eni5-G-H2. QA Inspector Brannon observed the OIW QC CWI Inspector's Mr. Steve Barnett and Mr. Jon Nickolich verifying that the pre-heat of 350°F and welding parameters were in accordance with the Welding Procedure Specification (WPS). Welding parameters measured by QA are as follows for root/fill: 586 amps, /36.0 volts and a travel speed of 457mm per minute appear to be in conformance with approved welding procedure specification WPS 4020 revision number 1.

QA Inspector Brannon randomly observed OIW qualified welder's Mr. Bounheune Savanh ID#S74 and Vincent Vu ID#V7 welding low spots using soudotape 316L stainless steel overlay to hinge k pipe beam fuse sub-assembly 120A-3. The weld joint is identified as 316L 3rd layer. Mr. Savanh and Mr. Vu was observed welding in the flat position utilizing automatic electro slag welding (ESW) overlay process with a .5mm x 60mm soudotape 316L stainless electrode, filler metal brand Soudotape class EQ316L automatic. QA Inspector Brannon observed the OIW QC CWI Inspector's Mr. Steve Barnett and Mr. Jon Nickolich verifying that the pre-heat of 20°C and welding parameters were in accordance with Welding Procedure Specification (WPS). Welding parameters observed by QA Inspector Brannon are as follows: 1180 amps, 25.7 volts and a travel speed of 267mm per minute appear to be in conformance with approved welding procedure specification (WPS 7003) revision number 0.

The following digital photograph below illustrates observation of the activities being performed.
