DEPARTMENT OF TRANSPORTATION

Contract #: 04-0120F4Cty: SF/ALA Rte: 80 PM: 13.2/13.9File #: 69.28**WELDING INSPECTION REPORT****Resident Engineer:** Pursell, Gary**Address:** 333 Burma Road**City:** Oakland, CA 94607**Report No:** WIR-007134**Date Inspected:** 15-May-2009**Project Name:** SAS Superstructure**OSM Arrival Time:** 900**Prime Contractor:** American Bridge/Fluor Enterprises, a JV**OSM Departure Time:** 700**Contractor:** Zhenhua Port Machinery Company, Ltd (ZPMC), Changxing Island **Location:** Shanghai, China**CWI Name:** See Below**CWI Present:** Yes No**Inspected CWI report:** Yes No N/A**Rod Oven in Use:** Yes No N/A**Electrode to specification:** Yes No N/A**Weld Procedures Followed:** Yes No N/A**Qualified Welders:** Yes No N/A**Verified Joint Fit-up:** Yes No N/A**Approved Drawings:** Yes No N/A**Approved WPS:** Yes No N/A**Delayed / Cancelled:** Yes No N/A**Bridge No:** 34-0006**Component:** OBG Fabrication**Summary of Items Observed:**

On this date CALTRANS OSM Quality Assurance (QA) Inspector, Mr. Paul Dawson, arrived on site at the Zhenhua Port Machinery Company (ZPMC) facility at Changxing Island, in Shanghai, China, for the purpose of monitoring welding an

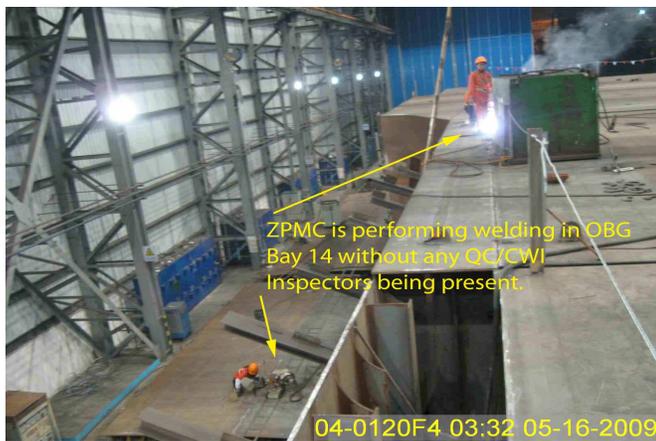
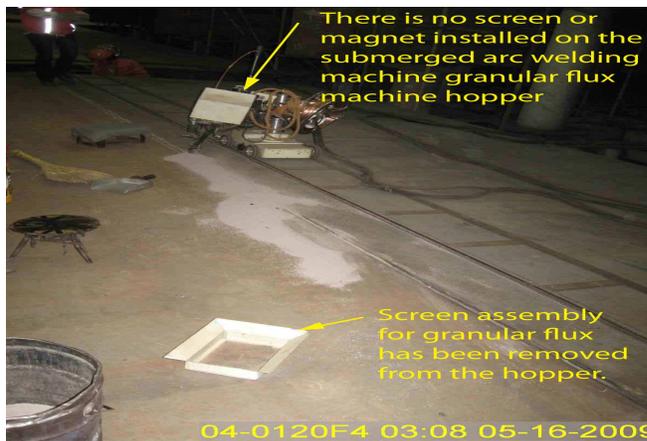
This QA Inspector observed ZPMC welder Ms. Xu Pei Pei, stencil 050323 is using the submerged arc welding process to make a groove weld between side plate SP132A and SP105A. The QA Inspector observed there does not appear to be any ZPMC Quality Control / Certified Welding Inspection personnel monitoring this welding for a period of over 30 minutes. The project Special Provisions, Section 8-3.01 states; "QC inspections shall be provided to ensure continuous inspection when any welding is being performed. Continuous inspection, as a minimum, shall include (1) having QC Inspectors continually present on the shop floor or project site when any welding operation is being performed, and (2) having a QC Inspector within such close proximity of all welders or operators so that inspections by the QC Inspector of each operation, at each welding location, shall not lapse for a period exceeding 30 minutes." This QA Inspector measured a welding current of approximately 630 amps and 30.0 volts. The QA Inspector observed the submerged arc welding machine hopper does not have any screen or magnet as required by AWS D1.5, Paragraph 4.8.4; where states: "SAW flux that has not been melted during the welding operation may be reused after recovery by vacuuming, use of catch pans, sweeping from weldment

surfaces or other means. Recovered flux shall be passed through an appropriate screen and over a suitable magnet to remove unwanted particles and materials before being returned to the flux supply system.” Items observed by this QA Inspector do not appear to be progressing in compliance with project specifications, and the QA Inspector issued a deviation report to document the lack of QC Inspections and not employing proper flux recovery equipment. See the photographs below for additional information.
