Contract #: 04-0120F4Cty: SF/ALA Rte: 80 PM: 13.2/13.9File #: 73.28**WELDING INSPECTION REPORT****Resident Engineer:** Pursell, Gary**Address:** 333 Burma Road**City:** Oakland, CA 94607**Report No:** WIR-007215**Date Inspected:** 09-Jun-2009**Project Name:** SAS Superstructure**OSM Arrival Time:** 800**Prime Contractor:** American Bridge/Fluor Enterprises, a JV**OSM Departure Time:** 1700**Contractor:** HoChang, Korea**Location:** Unyang/Changwon, Korea

Bridge No: 34-0006**Component:** Pier E2 Bearing and Shear Key**Summary of Items Observed:**

WELDING INSPECTION REPORT

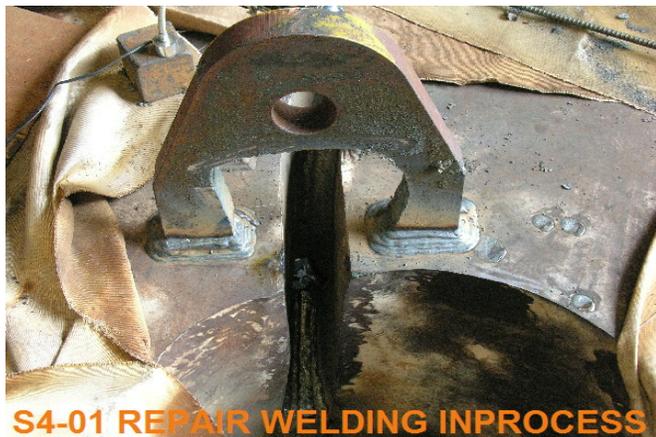
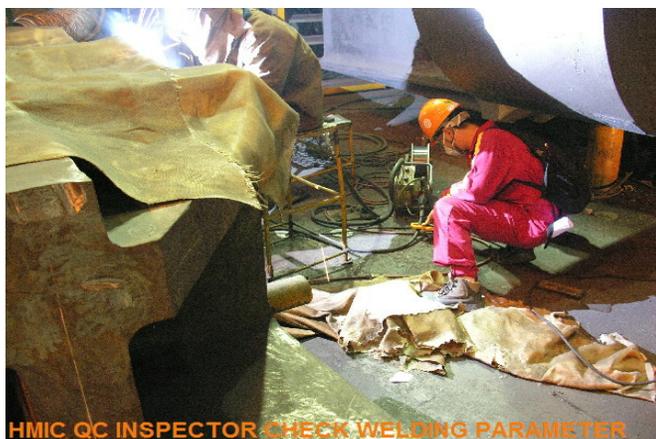
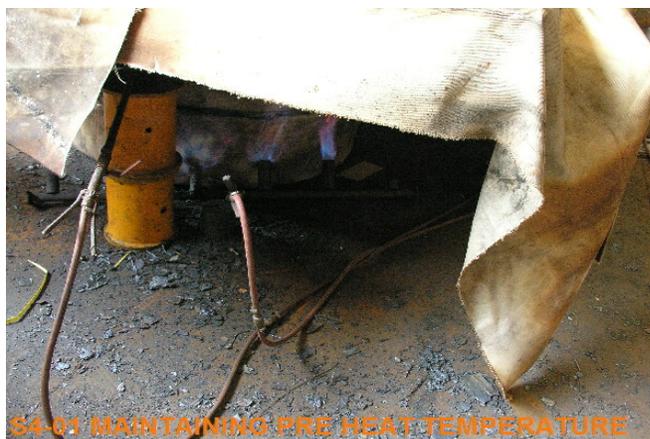
On this date the QA inspector observed DHIC performing repair welding on the castings listed below. This QA inspector, HMIC QC Inspector and DHIC QC inspector verified the welding parameters of the personnel listed below prior to the start of repair welding.

The QA inspector observed the welding process utilized Flux Core Arc Welding (FCAW) with filler metal E81T1-K2, 1.6mm diameter wire manufacture by SEAH-ESAB with brand name Dual shield 1181-K2.

This QA inspector verified the following welding parameters; 23-26 volts and 210-250 amps with a travel speed of 13-16 cm/min. The QA inspector observed a shielding gas flow of 10-25 l/min and a preheat temperature over 100°C which appeared to be maintained 24 hours a day.

The welding parameters observed appeared to comply with approved welding procedure specification; A-F-Z1Z1-219.

Please see photos below of QC personnel checking welding parameters, material used to maintain preheat temperature and repair welding in progress.
