DEPARTMENT OF TRANSPORTATION

Quality Assurance and Source Inspection

Contract #: 04-0120F4Cty: SF/ALA Rte: 80 PM: 13.2/13.9File #: 69.28**WELDING INSPECTION REPORT****Resident Engineer:** Pursell, Gary**Address:** 333 Burma Road**City:** Oakland, CA 94607**Report No:** WIR-007276**Date Inspected:** 09-Jun-2009**Project Name:** SAS Superstructure**OSM Arrival Time:** 700**Prime Contractor:** American Bridge/Fluor Enterprises, a JV**OSM Departure Time:** 1900**Contractor:** Zhenhua Port Machinery Company, Ltd (ZPMC), Changxing Island **Location:** Shanghai, China**CWI Name:** Chen Chih Chien**CWI Present:** Yes No**Inspected CWI report:** Yes No N/A**Rod Oven in Use:** Yes No N/A**Electrode to specification:** Yes No N/A**Weld Procedures Followed:** Yes No N/A**Qualified Welders:** Yes No N/A**Verified Joint Fit-up:** Yes No N/A**Approved Drawings:** Yes No N/A**Approved WPS:** Yes No N/A**Delayed / Cancelled:** Yes No N/A**Bridge No:** 34-0006**Component:** crossbeams and bike path cantilever brackets**Summary of Items Observed:**

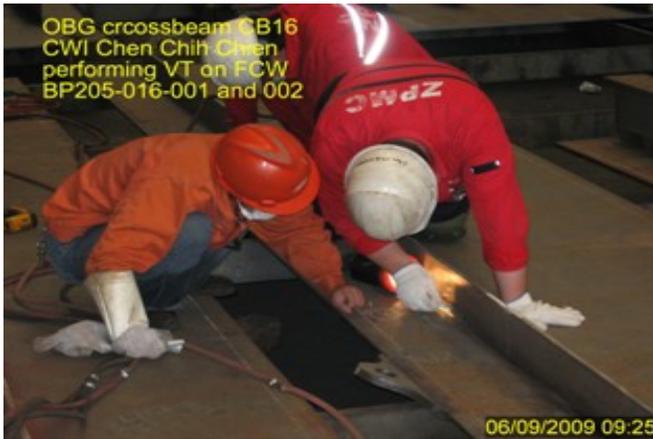
This QA observed ZPMC qualified welding personnel identified as 037748 perform SMAW repair welding on weld joints identified as BP205-016-001 and 002. ZPMC QC identified as Mr. Chen Chih Chien was present to monitor the welding process. The welding parameters as measured using QC's calibrated instruments appeared to be in general compliance with WPS-345-SMAW-2G (2F)-FCW-repair.
