DEPARTMENT OF TRANSPORTATION

Contract #: 04-0120F4Cty: SF/ALA Rte: 80 PM: 13.2/13.9File #: 13.28**WELDING INSPECTION REPORT****Resident Engineer:** Pursell, Gary**Address:** 333 Burma Road**City:** Oakland, CA 94607**Report No:** WIR-007408**Date Inspected:** 24-Jun-2009**Project Name:** SAS Superstructure**OSM Arrival Time:** 1400**Prime Contractor:** American Bridge/Fluor Enterprises, a JV**OSM Departure Time:** 2230**Contractor:** Oregon Iron Works Clackamas, Or.**Location:** Clackamas, OR

Bridge No: 34-0006**Component:** Hinge-K Components**Summary of Items Observed:**

Summary of Items Observed: On this date, Caltrans Quality Assurance Inspector (QA) Clete Henke was present at Oregon Iron Works, Inc. (OIW) in Clackamas, OR for observation of fabrication of the Hinge K Pipe Beams and related activities including in process welding and OIW Quality Control (QC) visual and nondestructive testing. The following observations were recorded:

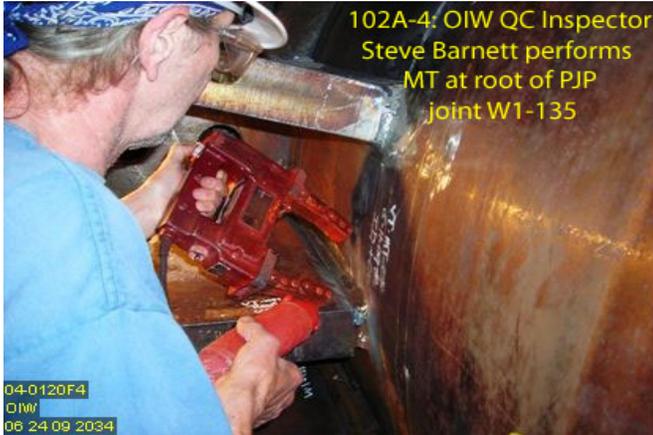
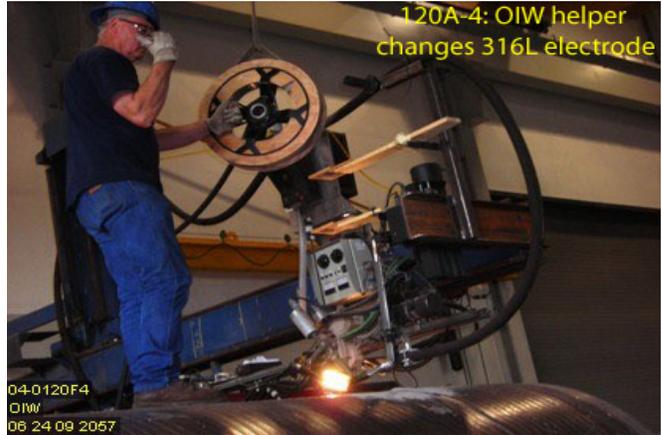
The QA Inspector intermittently monitored OIW welder Yuriy Bannikov (WID B61) during in progress Submerged Arc Welding (SAW) at weld joint WM3-02 joining a125 stiffener ring to a124-16 Fuse Section. Welder B61 deposited SAW fill and cover passes in the flat (1G) position in accordance with approved welding procedure 4020 at the location referenced above. The QA Inspector noted the OIW welder was maintaining continuous preheat utilizing two torches. An OIW helper was observed assisting welder B61 during SAW process.

The QA Inspector intermittently observed OIW qualified welder Bounheune Savanh (WID S74) during in-process welding of Soudotape 316L stainless steel overlay to hinge k pipe beam fuse sub-assembly 120A-4. The weld joint is identified as 316L 3rd layer. Mr. Savanh was observed welding in the flat position utilizing automatic electro slag welding (ESW) overlay process with a .5mm x 60mm Soudotape 316L stainless electrode, filler metal brand Soudotape class EQ316L automatic. An OIW helper was observed assisting welder V7 during ESW activity. The QA Inspector observed OIW QC Inspector Steve Barnett regularly monitoring and recording the in process ESW parameters. The QA Inspector also intermittently observed in process welding parameters and determined
