Contract #: 04-0120F4Cty: SF/ALA Rte: 80 PM: 13.2/13.9File #: 13.28**WELDING INSPECTION REPORT****Resident Engineer:** Pursell, Gary**Address:** 333 Burma Road**City:** Oakland, CA 94607**Report No:** WIR-007411**Date Inspected:** 25-Jun-2009**Project Name:** SAS Superstructure**OSM Arrival Time:** 700**Prime Contractor:** American Bridge/Fluor Enterprises, a JV**OSM Departure Time:** 1530**Contractor:** Oregon Iron Works Clackamas, Or.**Location:** Clackamas, OR**CWI Name:** Mike Gregson, Jose Salazar**CWI Present:** Yes No**Inspected CWI report:** Yes No N/A**Rod Oven in Use:** Yes No N/A**Electrode to specification:** Yes No N/A**Weld Procedures Followed:** Yes No N/A**Qualified Welders:** Yes No N/A**Verified Joint Fit-up:** Yes No N/A**Approved Drawings:** Yes No N/A**Approved WPS:** Yes No N/A**Delayed / Cancelled:** Yes No N/A**Bridge No:** 34-0006**Component:** Hinge K Pipe Beams**Summary of Items Observed:**

The Quality Assurance Inspector Sean Vance arrived on site at Oregon Iron Works, Inc (OIW) in Clackamas, OR, to randomly observe the in process welding of the Hinge K Pipe Beam assemblies. The QA Inspector arrived on site to randomly observe the OIW Quality Control (Q

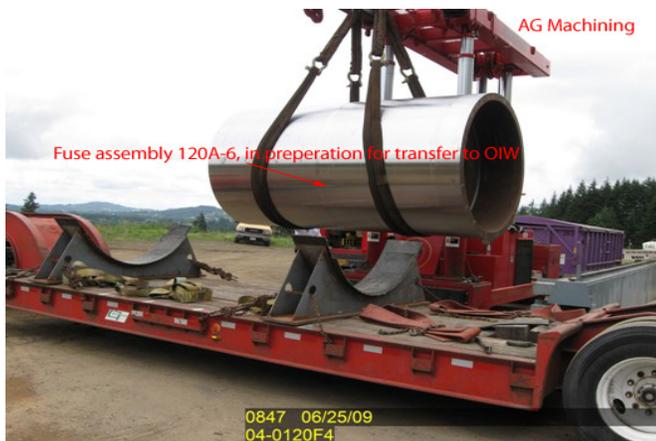
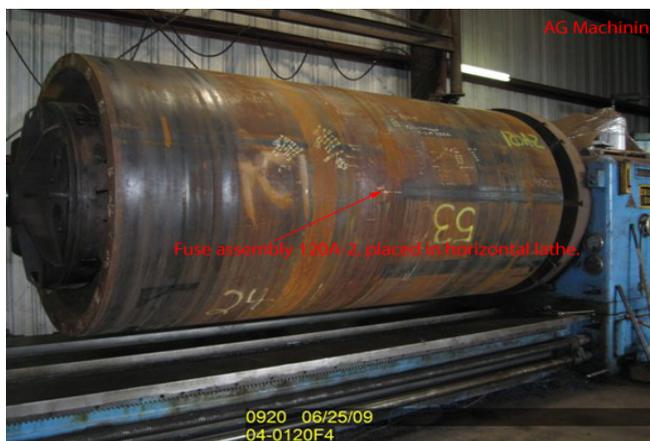
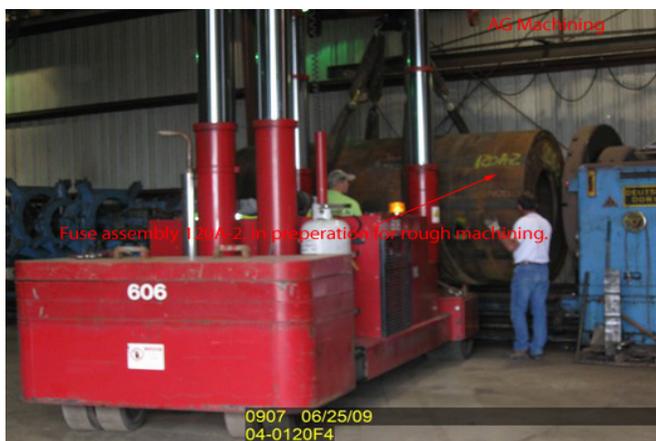
QA Inspector arrived at A&G Machining, on this date and A&G explained that this fuse assembly 120A-6 rough machining had been previously completed and was in-process of being transferred back to OIW fabrication shop. QA Inspector witnessed the fuse assembly 120A-6 being loaded onto a trailer, in preparation for transfer back to OIW and fuse assembly 120A-2 being placed in the horizontal lathe, in preparation for rough machining. A&G explained that roundness measurements would be taken by A&G machinist and OIW machinist would be arriving later in the afternoon, to verify measurements and potentially release this fuse assembly 120A-2 to A&G, to begin rough machining, on this date. A&G also explained that final outside diameter measurements were taken by A&G, on fuse assembly 120A-6 and were verified by OIW machinist on 6/24/09, as shown below and OIW released this fuse assembly 120A-6. QA Inspector noted that these final outside diameter measurements appeared to be in compliance with the contract requirements of 1900mm, final outside diameter after rough machining (+/- 3mm). See attached pictures below of fuse assemblies 120A-2 and 120A-6.

Final outside diameter measurements of fuse assembly 120A-6:
