**DEPARTMENT OF TRANSPORTATION**

Contract #: 04-0120F4Cty: SF/ALA Rte: 80 PM: 13.2/13.9File #: 13.28**WELDING INSPECTION REPORT****Resident Engineer:** Pursell, Gary**Address:** 333 Burma Road**City:** Oakland, CA 94607**Report No:** WIR-007451**Date Inspected:** 15-Jun-2009**Project Name:** SAS Superstructure**OSM Arrival Time:** 1700**Prime Contractor:** American Bridge/Fluor Enterprises, a JV**OSM Departure Time:** 130**Contractor:** Oregon Iron Works Clackamas, Or.**Location:** Clackamas, Oregon

**Bridge No:** 34-0006**Component:** Hinge K Pipe Beams**Summary of Items Observed:**

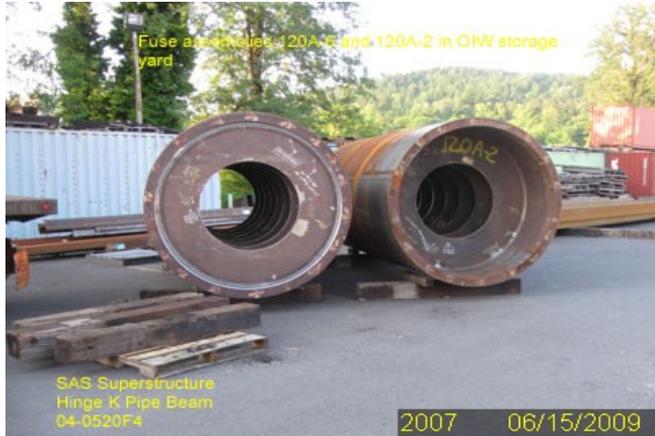
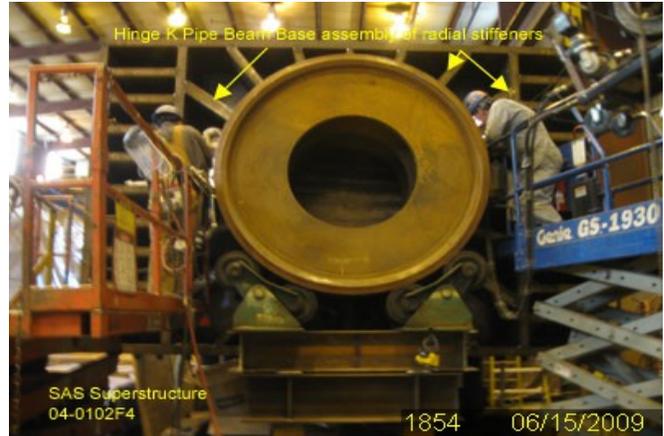
QA Inspector Brannon randomly observed OIW qualified welder Mr. Mikhail Bannikov ID#B28 welding fill pass's joining radical stiffener MK #b108 (HPS 485 W) to tubular forging MK# a111-4 (A508 Gr. 4N Class 2) for hinge k pipe beam base assembly section a102-4. The partial joint penetration (PJP) groove weld is identified as weld joint #W1-160. Mr. Bannikov was observed welding in the 1G (flat) position utilizing submerged arc welding (SAW) process with a 2.4mm diameter electrode, filler metal brand Lincoln Electric LA85 class F9A4-Eni5-G-H2. QA Inspector Brannon observed the OIW QC CWI Inspector Mr. Steve Barnett verifying that the pre-heat of 350°F and welding parameters were in accordance with the Welding Procedure Specification (WPS). Welding parameters measured by QA are as follows for root/fill: 568 amps, /34.7 volts and a travel speed of 431mm per minute appear to be in conformance with approved welding procedure specification WPS 4016 revision number 1.

QA Inspector Brannon randomly observed OIW qualified welder Mr. Liam Bui ID#B10 welding fill pass's joining radical stiffener MK #c107 (HPS 485 W) to vertical stiffener MK#a107 (HPS 485 W) for hinge k pipe beam base assembly section a102-4. The partial joint penetration (PJP) groove weld is identified as weld joint #W1-97. Mr.

Bui was observed welding in the 1G (flat) position utilizing submerged arc welding (SAW) process with a 2.4mm diameter electrode, filler metal brand Lincoln Electric LA85 class F9A4-Eni5-G-H2. QA Inspector Brannon observed the OIW QC CWI Inspector Mr. Steve Barnett verifying that the pre-heat of 350°F and welding parameters were in accordance with the Welding Procedure Specification (WPS). Welding parameters measured by QA are as follows for root/fill: 582 amps, 34.5 volts and a travel speed of 430mm per minute respectively appear to be in conformance with approved welding procedure specification WPS 4020 revision number 1.

The following digital photograph below illustrates observation of the activities being performed.
